Inspection / Replacement of Teeter Stops

Inspect the height of the teeter stop and replace, if necessary.

Manufacturer Bulletin 01/2012

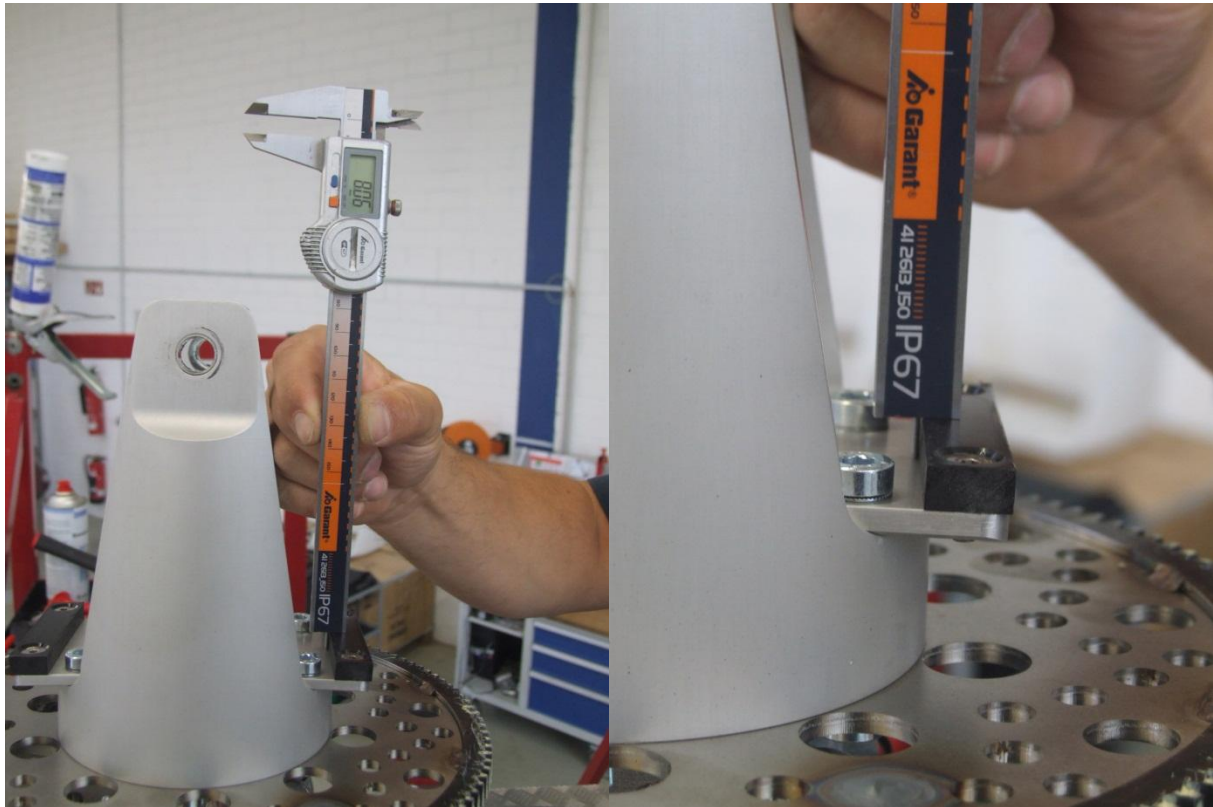
Routine quality control revealed out-of-tolerance teeter stops. It is probable that a certain number of rotor heads with out-of-tolerance teeter stops have been manufactured and delivered. Due to the fact that the faulty teeter stops are slightly too high the faulty condition does not represent a danger in normal operation.

Measure height of teeter stops with a calliper. If height complies with the nominal dimension of 7 +/- 0.2 mm no further action is required.

Measuring the height of the teeter stop

(Measurement shows an out-of-tolerance teeter stop)

In case of deviation the teeter stops have to be replaced as instructed below.

1. Remove rotor system acc. to POH 8.15.1 or Maintenance Manual
2. Remove teeter stops
3. Position new teeter stops, apply LOCTITE 243 to the threads of the attachment bolts and torque with 6 Nm.
4. Install rotor system acc. to POH 8.15.4 or Maintenance Manual
