Service Information Letter

AG-SIL-2019-03-EN	Issue: 1	Dated: 13.09.2019	
<p>The purpose of this document is to communicate information that may be of benefit to pilot owners of AutoGyro Gyros. If there is any clarification required of the content of the letter, contact the addressee stated at the bottom of the page</p>			
Aircraft type & model applicability:		Aircraft serial numbers affected:	
All AutoGyro gyroplanes		All	
Subject: Rotor blade inspection guidelines			
Safety effect:			
<p>The purpose of this document is to provide inspectors with more information regarding inspection processes for rotor blades</p>			
Weight and CG effect:			
None			
Background:			
<p>The 25 and 100hr maintenance checklist for all AutoGyro gyroplanes requires careful inspection of the rotor blades for cracks or damage.</p> <p>This document is designed to offer more information of what and where to inspect</p>			
Discussion:			
<p>The inspection of the rotor is a requirement within the 100hr service documents.</p>

All AutoGyro gyroplanes

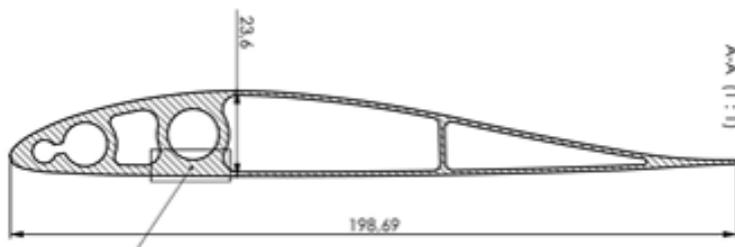
RotorSystem II extrusion.

The blade extrusion inner profile differs between RSI and RSII. See below.

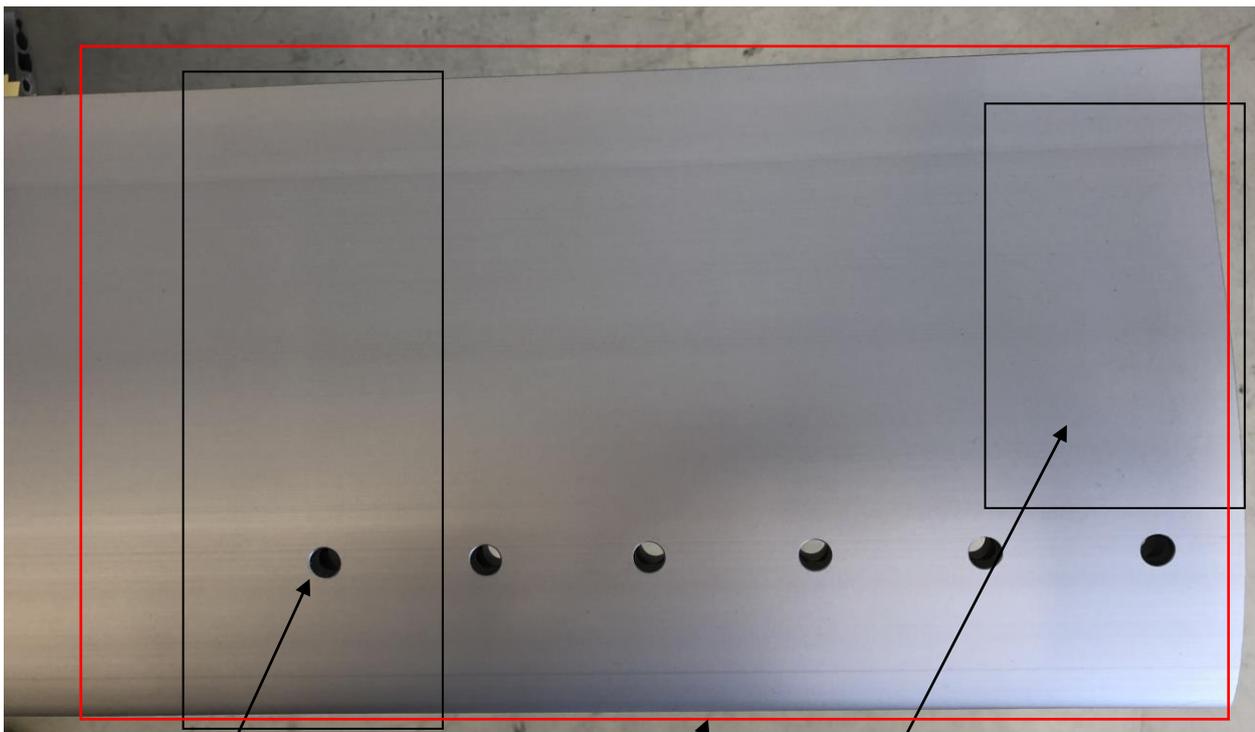
View of the top side of the rotor root (RSII, 6-hole attachment. The same applies to this area on the 9-hole attachment).

Outboard bolt hole area. Both upper and lower surfaces must be carefully inspected. No cracks, splits, dents or defects allowed +/-100mm either side of this hole.

No bending of the blade in any plane permissible in this area.

Area of possible crack in upper surface. Inspected either during strip down, or by removing the inner end cap and viewing in side the extrusion end with a bright lamp. See later note and photos.

The entire root area connection to the hub bar is of importance. Holes must be clean and free of burrs and corrosion. Fretting between the clamp profile (that sets the angle of blade incidence to the hub) should be minimal and not rubbing into the blade surface. Light damage to the trailing edge area, rear of the clamp profile, is permissible.

The RotorSystem I blade to hub bar joint must be strip-inspected every 100hrs (due to the lower safe life)
The RotorSystem II blade to hub bar joint must be strip-inspected every 500hrs (1/5 of the safe life limit).

See SB-034 for RotorSystem I.

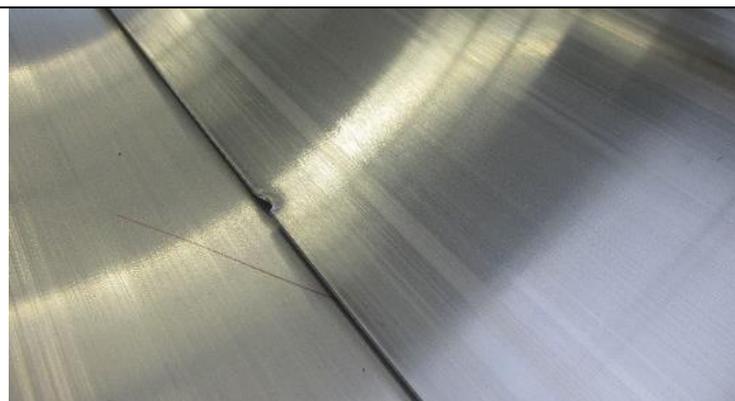
Trailing edge damage.

The photo shows an example of trailing edge damage. A ding in the trailing edge may be flatted out and the rotors continued in service provided that the ding does not cause a fracture into the inner part of the extrusion, and is not within 1m of the hub bar connection.

Small damage resulting in a light bend (1-2mm, typically at the rotor tip) may be straightened carefully to the same profile as the rest of the blade section. More damage must be discussed with AutoGyro technicians. Remember, damage that changes the aerodynamic profile will affect the flight characteristic of the blade in that area. The further outboard the damage is, the faster the blade is turning, and thus the aerodynamic effect is greater.

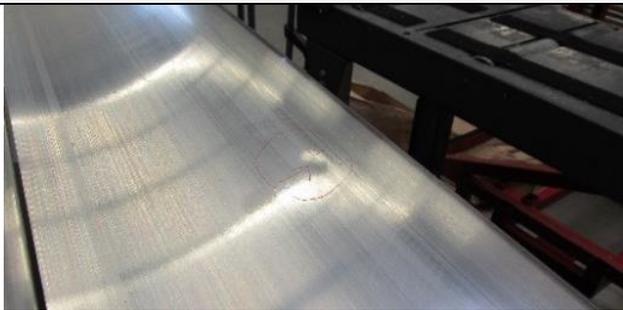
Dents in the upper or lower surfaces (such as the photo above) more than 1m from the hub bar up to 10mm in diameter are unlikely to cause a stress raiser and may be left in service and monitored by the user

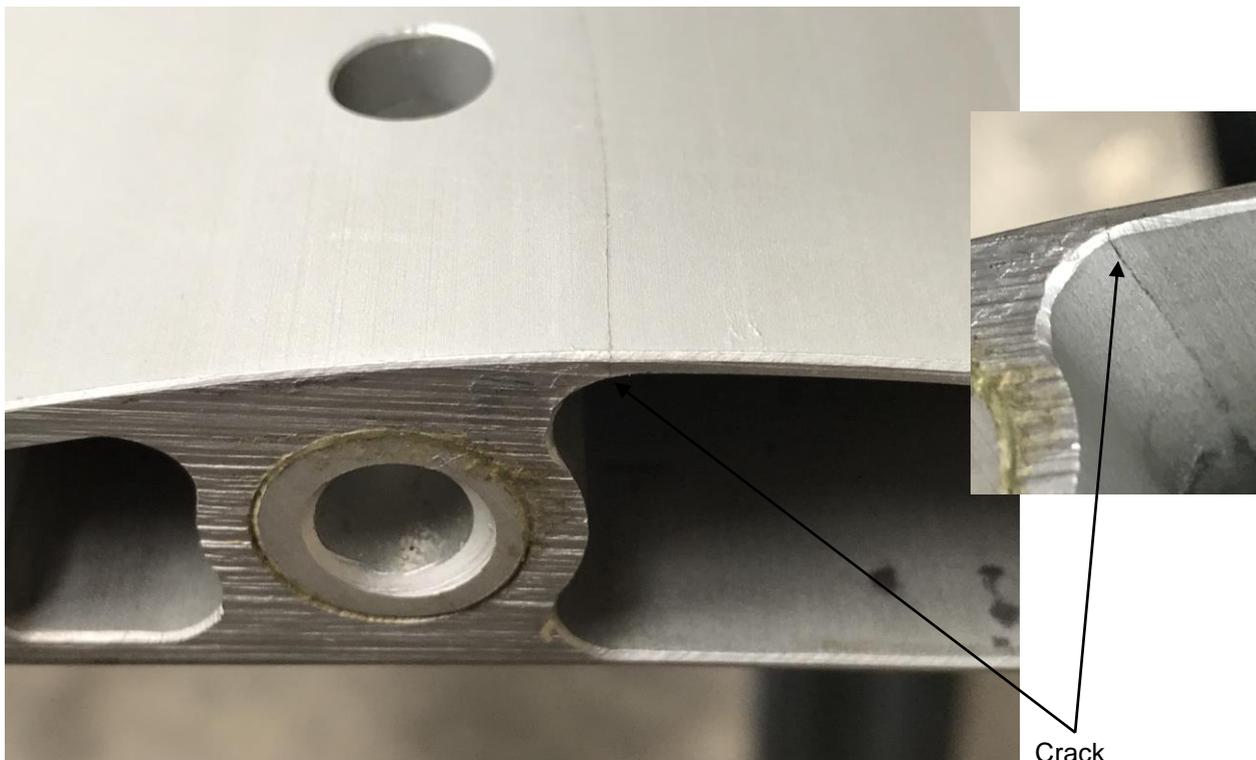
Longitudinal blade root crack, adjacent to bolted area.

Photo of a longitudinal blade root crack, and inset a photo taken viewing from inside the blade with the inner end cap removed.

The presence of such a crack can be easily inspected by removing the blade inner end cap, and viewing with a bright torch.
