Title: Torque / Washer Check L/H Lower Engine Mount Rotax 915 iS		
AG-SB-2023-04-B-EN	Effective Date: 09.10.2023	Compliance Category:
Applicability		A - MANDATORY B - RECOMMENDED C - OPTIONAL
Aircraft type & model: All aircraft with a Rotax 915 iS engine and a fixed nut on the left lower engine mount	Affected Serial number(s): All aircraft	
The maintenance manual to be referenced is this stated or subsequent issue.		As per AutoGyro website
This form is the response from AutoGyro GmbH either against a problem found in the product in service requiring a containment or rectification action, or as service information for aircraft modification incorporation. For help, contact airworthiness@auto-gyro.com .

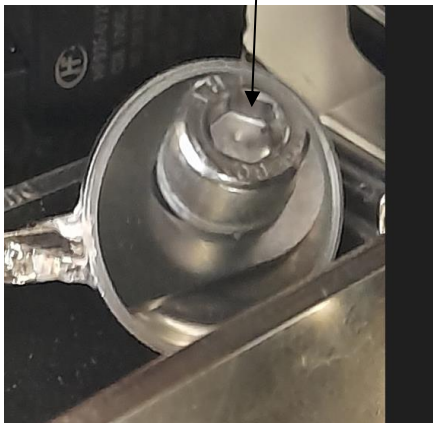
Bolt with Nord-Lock washer

If the aircraft is NOT fitted with a Nord-Lock washer on the lower left hand engine mount, carefully loosen the nut and remove the bolt. Support the engine with a crane or similar if necessary. Install the Nord-Lock washer (convex side facing bolt head) and put the bolt back in, release the engine from the crane if this has been done and torque the bolt with 56Nm.

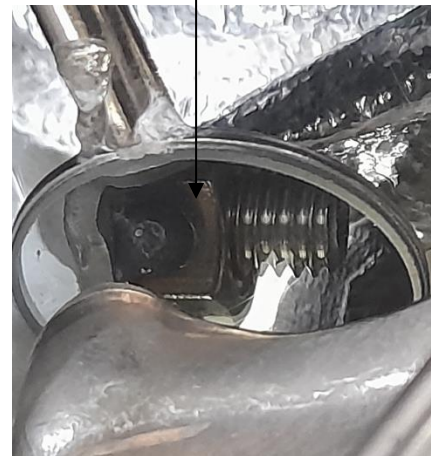
Fixed nut on the turbo charger bracket
