Title: Heater Upgrade II.1		
AG-SB-2023-05-B-EN	Effective Date: 01.12.2023	Compliance Category: A - MANDATORY B - RECOMMENDED C - OPTIONAL
Applicability		
Aircraft type & model: Cavalon	Affected Serial number(s): built after 05/2022 and before 10/2023	
The maintenance manual to be referenced is this stated or subsequent issue.		As per AutoGyro website
This form is the response from AutoGyro GmbH either against a problem found in the product in service requiring a containment or rectification action, or as service information for aircraft modification incorporation. For help, contact airworthiness@auto-gyro.com .

Reason and overview of the Service Bulletin (cause of problem if known)

A number of early generation heater-valve units were found to be defective and started to leak. This early generation is now superseded by a new design, shown in service to be more reliable.

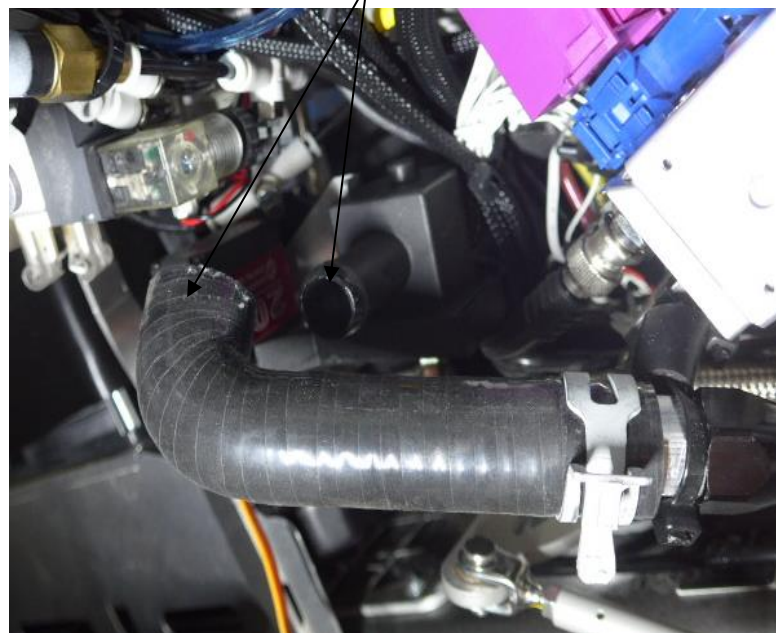
Clamp removed, hose removed from old valve unit, here to see on the left side, same on the other side with the clamp
