Title: Retrofit of an additional heat protection for the lower ignition cables for 915iS			
AG-SB-2024-2-B-EN	Effective Date:	Compliance Category:	
Applicability		A - MANDATORY	
Aircraft type & model:	Affected Serial number(s):	B – RECOMMENDED	
Cavalon	All fitted with Rotax 915iS engines up to serial V00564	C - OPTIONAL	
The maintenance manual to be referenced is this stated or subsequent issue.		As per AutoGyro website	
This form is the response from AutoGyro GmbH either against a problem found in the product in service requiring a containment or rectification action, or as service information for aircraft modification incorporation. For help, contact airworthiness@auto-gyro.com.

#### Reason and overview of the Service Bulletin (cause of problem if known)

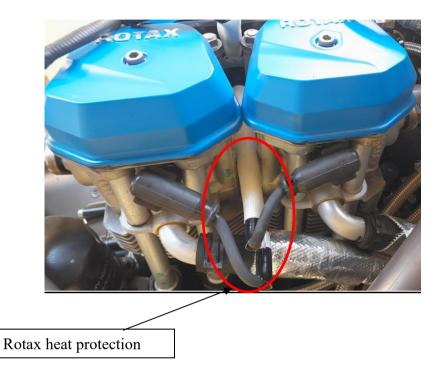
Old version with only Rotax heat protection:

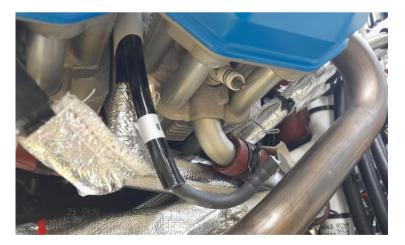
Cable tie and spark plug connector removed:

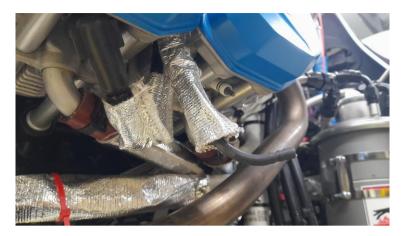
Installed additional heat sleeve:

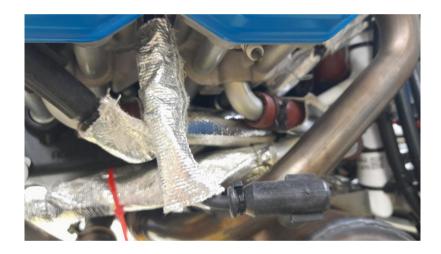
Spark plug connector screwed back on and new cable tie installed:
