Title: Inspection and Replacement of the roll and pitch bolt		
AG-SB-2024-03-B-EN	Effective Date: 20.03.2024	Compliance Category: A – MANDATORY B – RECOMMENDED C – OPTIONAL
Applicability		
Aircraft type & model: All models	Affected Serial number(s): All models built between 05.2023 and 02.2024, Affected serial numbers in the description	
The maintenance manual to be referenced is this stated or subsequent issue.		As per AutoGyro website
This form is the response from AutoGyro GmbH either against a problem found in the product in service requiring a containment or rectification action, or as service information for aircraft modification incorporation. For help, contact airworthiness@auto-gyro.com .

This service bulletin provides instructions on how to inspect and replace the roll/pitch bolt with part number 20675.

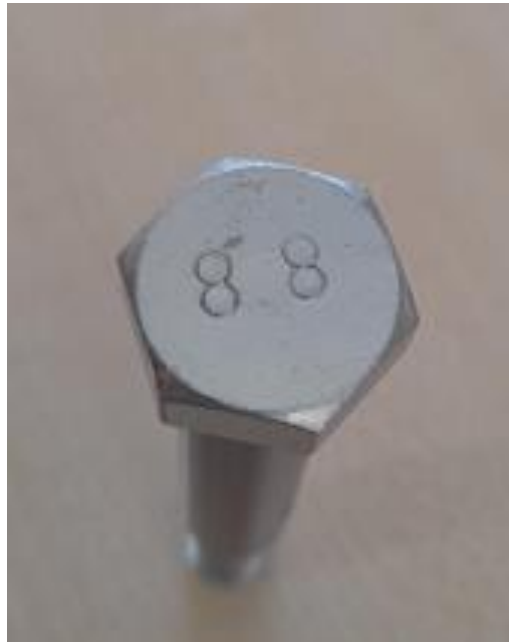
Marking of the incorrect bolt:

A processing error has meant that a number of pitch/roll bolts have been manufactured with a longer lead-in chamfer than required. Whilst there is considered to be no structural or flight safety effect, the part does not meet the AutoGyro engineering standards.

If the screw head looks like this the bolt needs to be replaced.

MTOsport 2010; If affected, then both pitch and roll bolts are to be changed.

MTOsport 2017, Cavalon and Calidus; If affected, then only the roll bolts are to be changed.

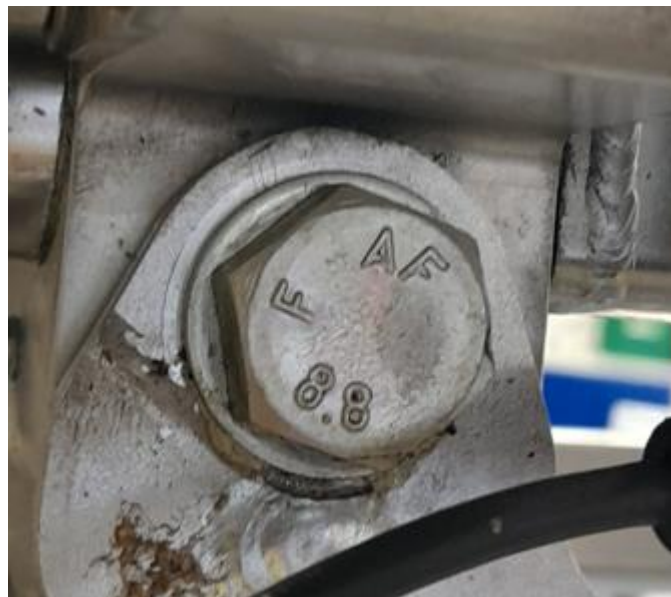
Marking of the correct bolt:

If the screw head looks like this a replacement is not necessary
