**AG-SB-2017-03-B-EN – MT03 control rod**

**Category B**

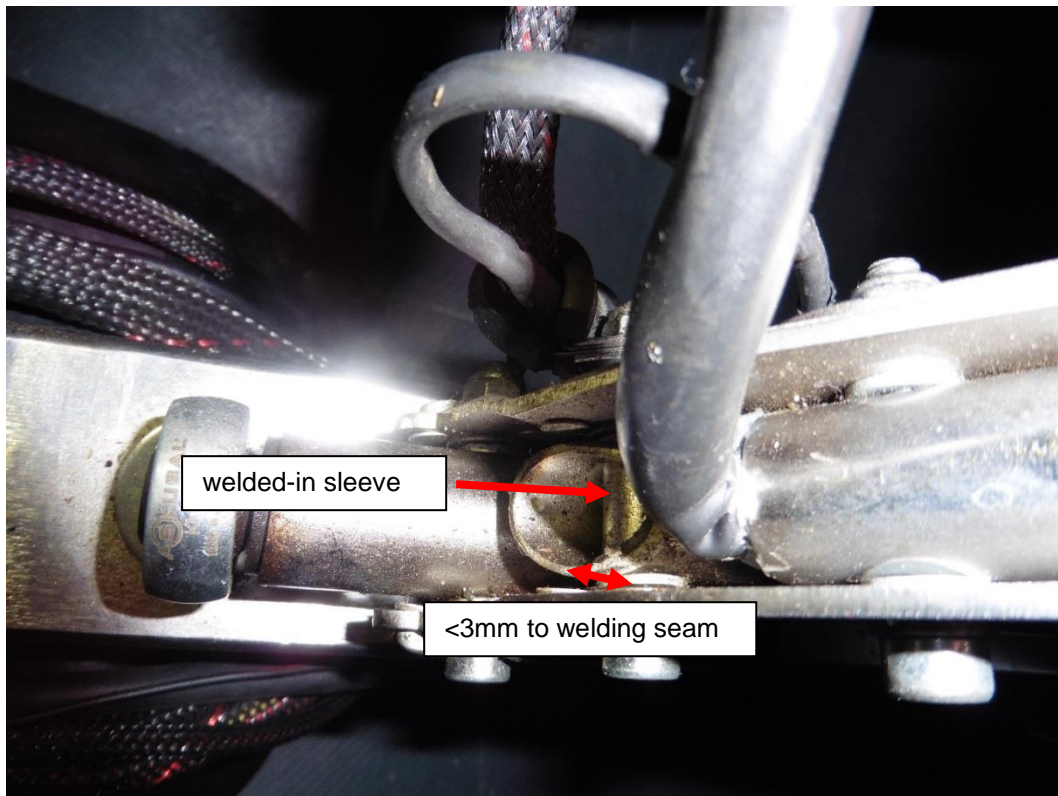
This Service Bulletin is applicable for all MT03 and converted MT03 to MTOsport until 12 / 2007, where the control rod is cut diagonally (see fig.1).

A case was found with a failed weld and subsequent tube failure at the upper control rod joint to the front control stick. Normally this would be found during maintenance or pre-flight inspection, so the purpose of this SB is to highlight the need to check this part.

**Fig. 1: old control rod with diagonally cut**

- Inspect that the welded-in sleeve inside the end of the tube is secure, and no evidence of weld failure.
- Inspect if the control rod has been cut down more than 3mm between the end of the rod and the outer wall of the welding seam.
- Rectification: replace the control rod if cut down limit of 3mm is exceeded.

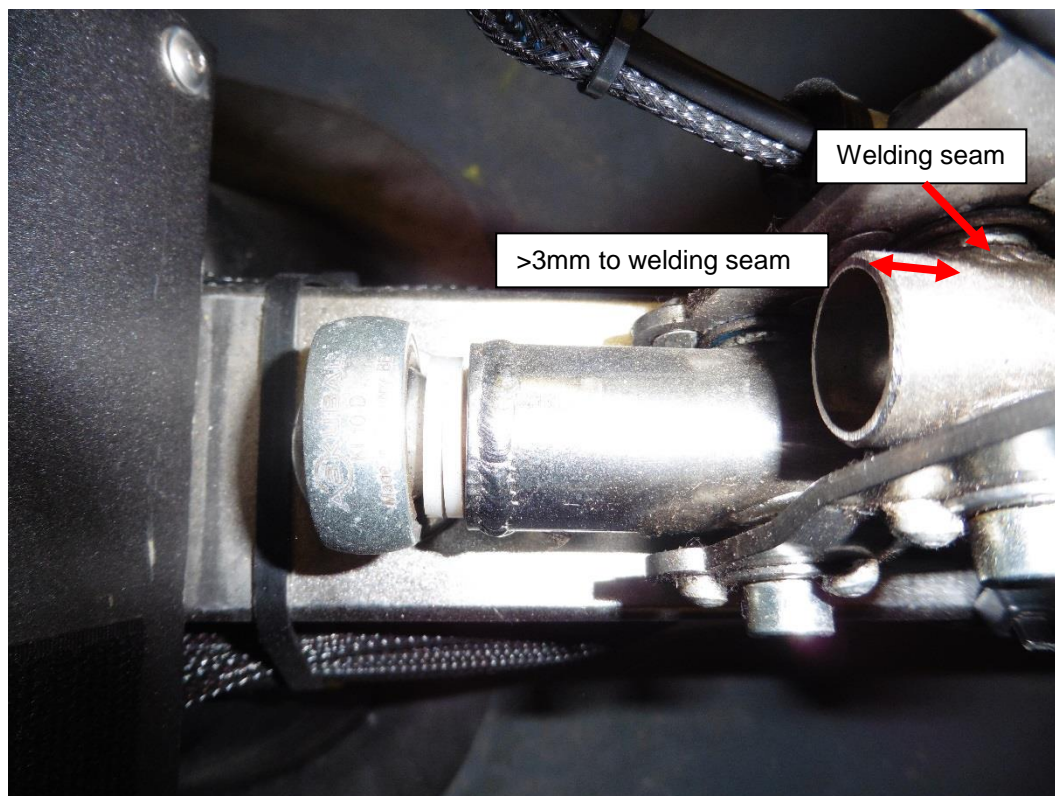
**Fig. 2: new control rod without cut**

Additionally, the check provides an opportunity to replace the existing tube with a later generation improved part should the original fall outside of the recommended dimensions.
