| Title: Capacitor Cavalon | | Compliance Category: A - MANDATORY B - RECOMMENDED C - OPTIONAL |
| AG-SB-2018-02-B-EN | Applicability | |
| Aircraft type & model: Cavalon with a Super B Battery, in which the Service Bulletin AG_MI_2014_05_C was not executed | Affected Serial number(s): | |

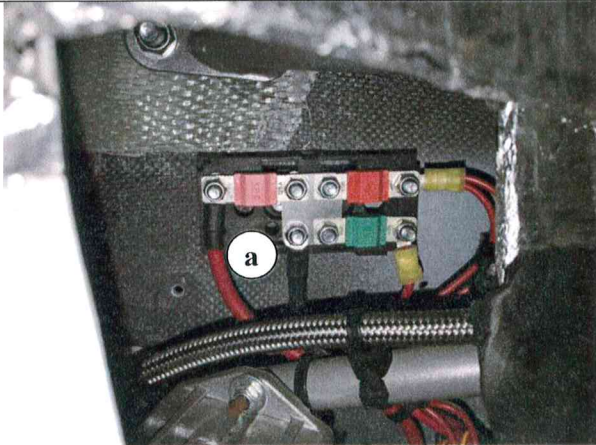
fig 1: fuse carrier (a), no capacitor

If no capacitor is installed, it must be retrofitted as follows:

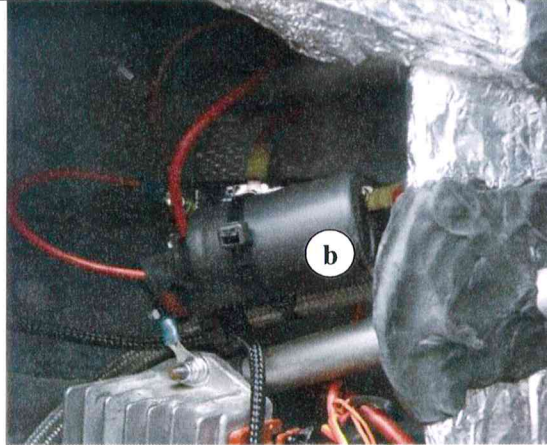
fig 2: no capacitor (b)
