Title: Cavalon window strength improvement		
AG-SB-2022-08-C-EN	Effective Date: 26.09.2022	Compliance Category: A - MANDATORY B - RECOMMENDED C - OPTIONAL
Applicability		
Aircraft type & model: AutoGyro Cavalon	Affected Serial number(s): Up to SN V00533	
The maintenance manual to be referenced is this stated or subsequent issue.		As per AutoGyro website
This form is the response from AutoGyro GmbH either against a problem found in the product in service requiring a containment or rectification action, or as service information for aircraft modification incorporation. For help, contact airworthiness@auto-gyro.com .

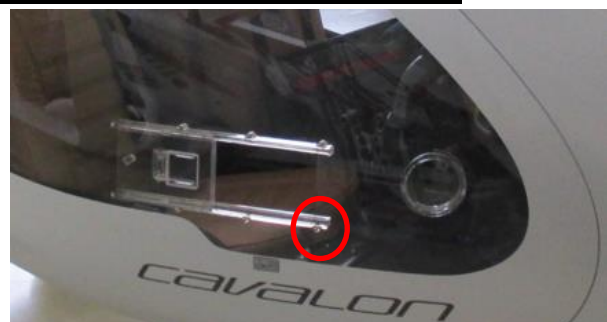
Due to improper opening and closing of the door via the ventilation window, cracks occasionally occur at the front lower corners of the ventilation windows at the screw connection.

- Uninstall the lower front screw
- Clean the outside surface of the cabin door with active glass cleaner (PN 30494)
