Title: Inspection of Rotor head		
AG-SB-2022-09-B-ENR2	Effective Date: 07.10.2022	Compliance Category:
Applicability		A - MANDATORY B - RECOMMENDED C - OPTIONAL
Aircraft type & model: All Cavalon and Calidus with Rotor head III	Affected Serial number(s): All Cavalon and Calidus with Rotor head III	
The maintenance manual to be referenced is this stated or subsequent issue.		As per AutoGyro website
<p>This form is the response from AutoGyro GmbH either against a problem found in the product in service requiring a containment or rectification action, or as service information for aircraft modification incorporation. For help, contact airworthiness@auto-gyro.com.</p>

The purpose of this SB is to highlight the need for effective pre-flight and service inspection of the weld that joins the rotor head side plate to the roll link bracket.

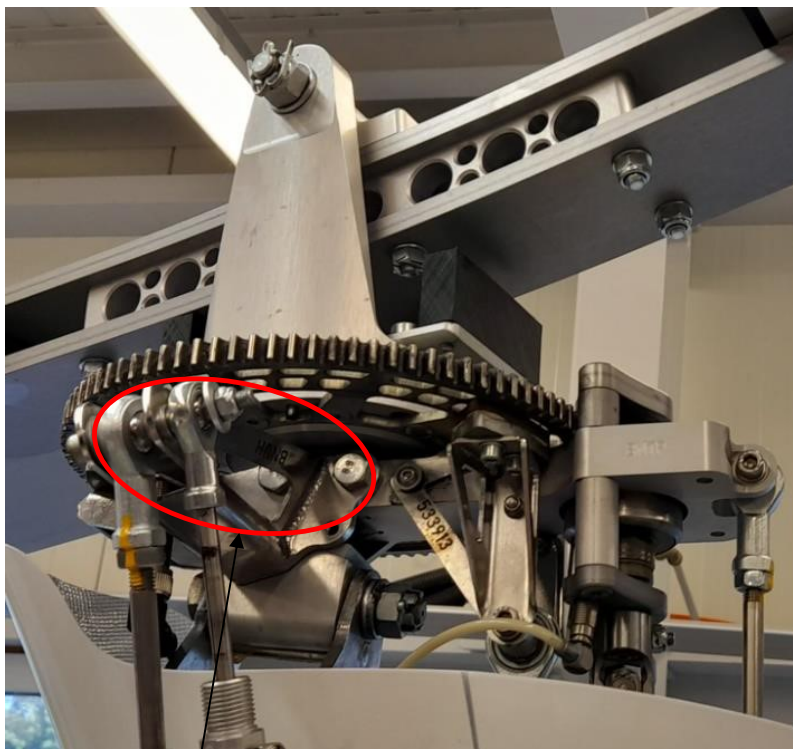
Rotorhead III

Pre-flight inspection requires a thorough review of the rotorhead. Pilot/operators are reminded that this includes the welded connection between the side plates and roll link bracket shown below. This area is open for easy inspection.

If a crack is found, the part is to be replaced in accordance with normal maintenance procedures.

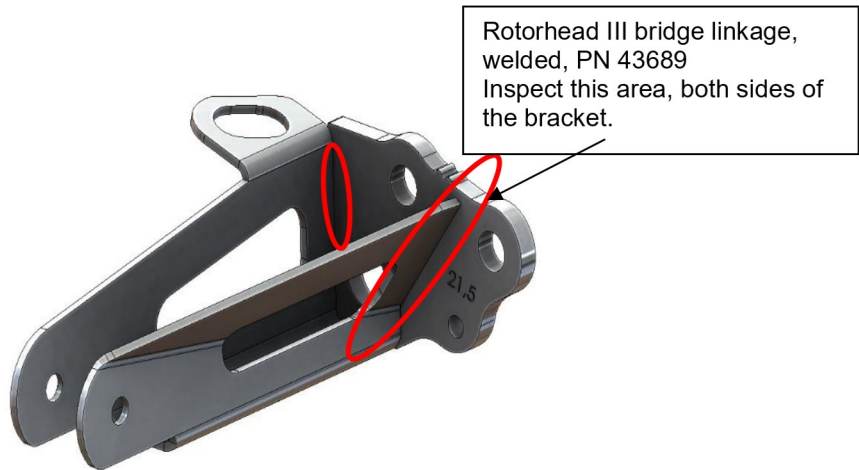
The ringed area indicates the installed bridge linkage

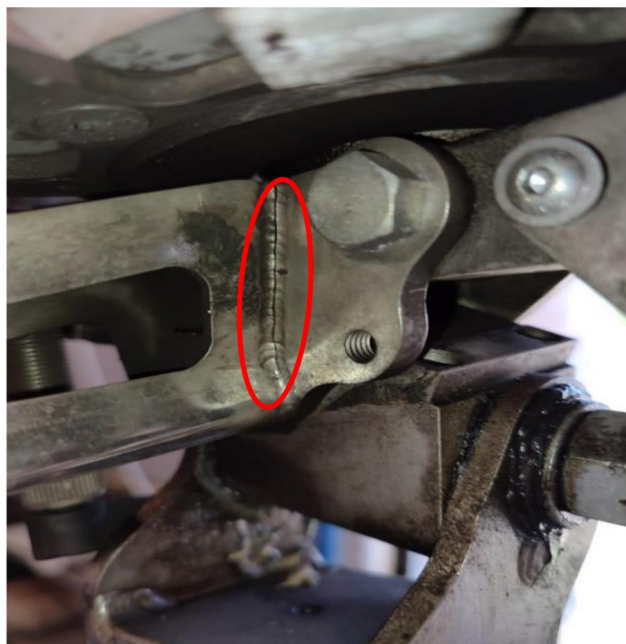
Reason; a small number of 1st generation Rotorhead III Rotor head bridge roll linkage assemblies were found during service inspection to have a weld crack. The inspection in this area is considered to be part of the pre-flight inspection, and the area is easily visually inspectable.

External weld with crack:
This area is readily inspected during pre-flight inspection

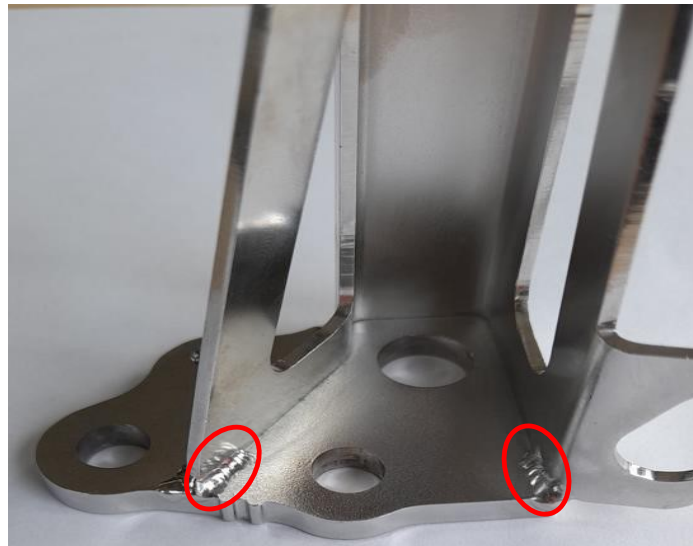
There are two generations of the Rotorhead III Rotor head bridge roll linkage assemblies. The second generation is welded on the inside upper end of the bracket, see photo, and was released in 2019. Only this later generation is available, and is fully interchangeable with the earlier version.

Note: these assemblies are stamped with the size (21.5 and 22.5). If replacing, ensure that the correct size is fitted!

Replacement parts if required
45966, Rotor head bridge roll linkage 22,5 welded (Cavalon)
43689, Rotor head bridge roll linkage 21,5 welded (Calidus)
