Title: Heater Upgrade II.1		
AG-SB-2023-05-B-ENR1	Effective Date: 01.12.2023	Compliance Category: A - MANDATORY B - RECOMMENDED C - OPTIONAL
Applicability		
Aircraft type & model: Cavalon	Affected Serial number(s): built after 05/2022 and before 10/2023	
The maintenance manual to be referenced is this stated or subsequent issue.		As per AutoGyro website
This form is the response from AutoGyro GmbH either against a problem found in the product in service requiring a containment or rectification action, or as service information for aircraft modification incorporation. For help, contact airworthiness@auto-gyro.com .

Reason and overview of the Service Bulletin (cause of problem if known)

A number of early generation heater-valve units were found to be defective and started to leak. This early generation is now superseded by a new design, shown in service to be more reliable.

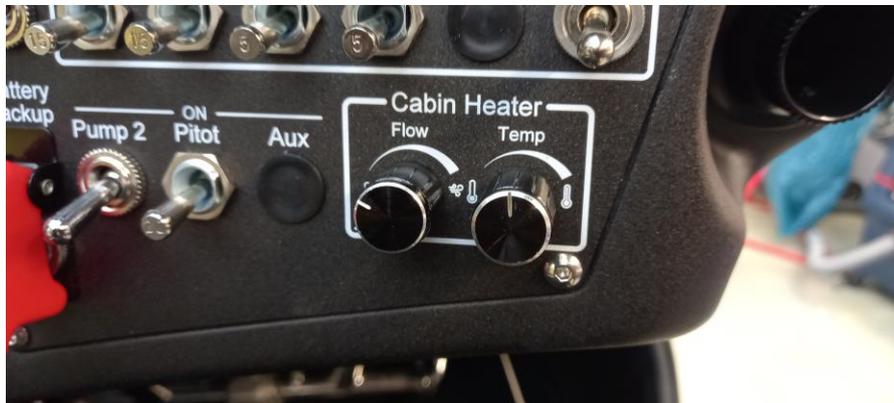
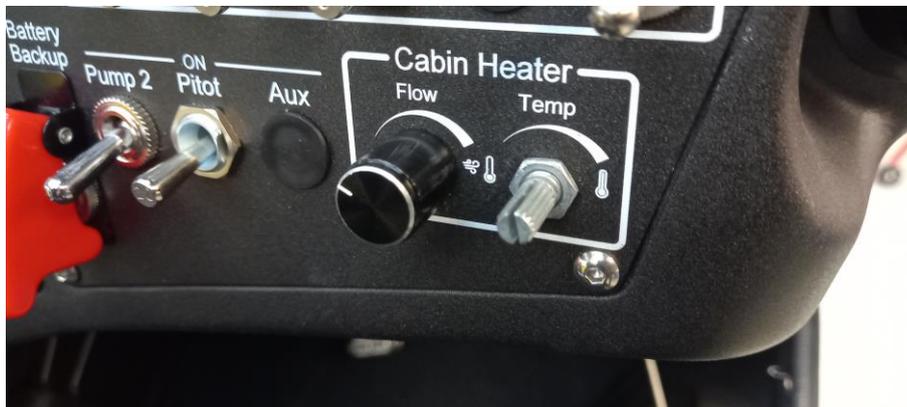
- 1.) Remove the cap of the rotary control by pulling it off.

2.) Loose the nut and remove the potentiometer to the backside of the panel.

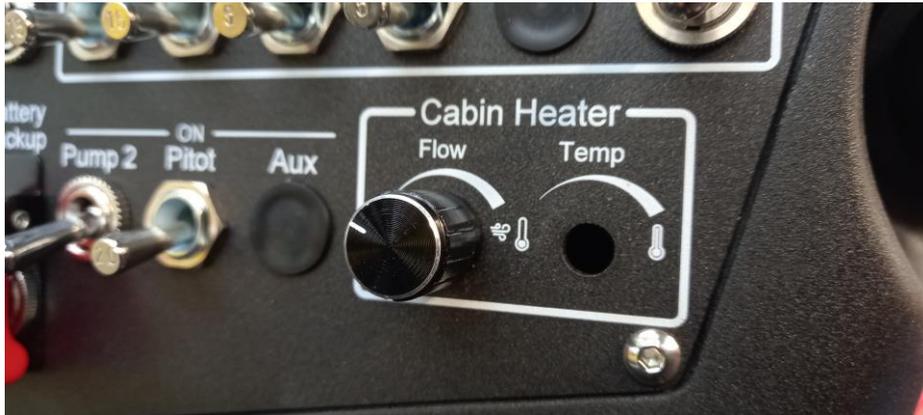
3.) Cut two pieces of shrink sleeve to 10mm and put in on both sides of the electrical resistor.

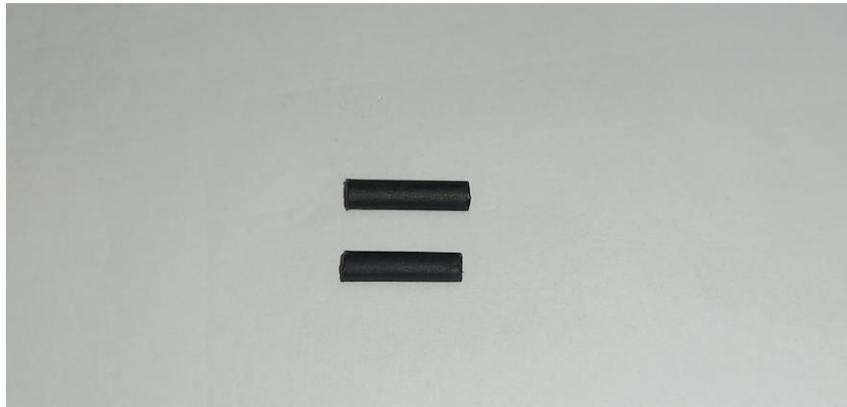
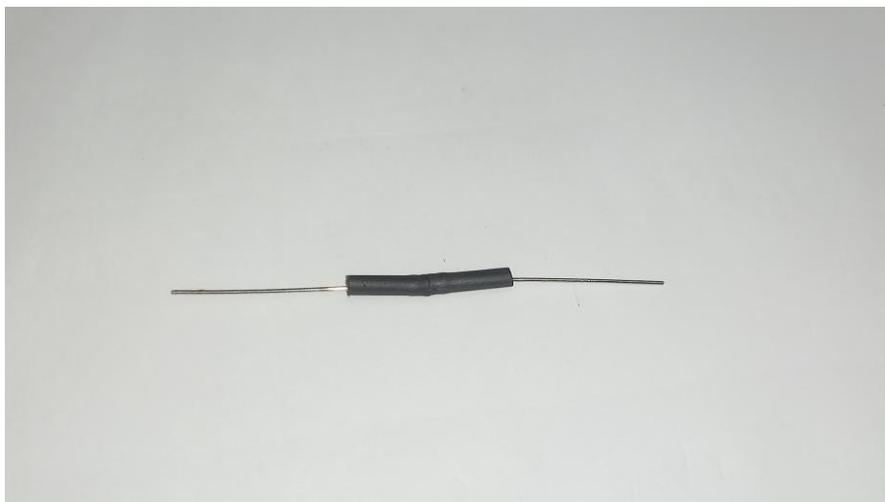
- 4.) Shrink the sleeve and cut both ends of the resistance to approximately 4mm.

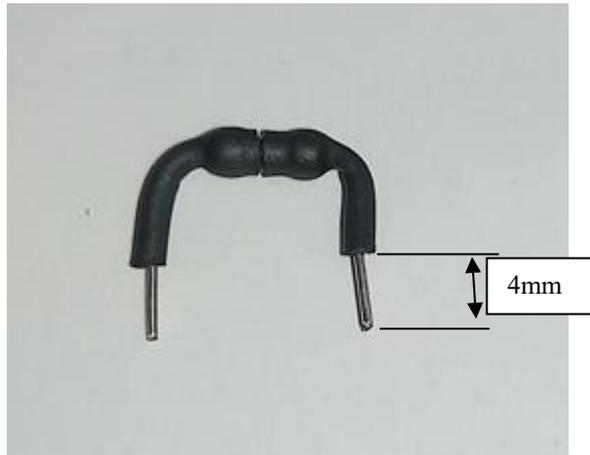
- 5.) Install the resistance onto the potentiometer (be careful to cover the potentiometer against Solder) – check afterwards for secure connection.

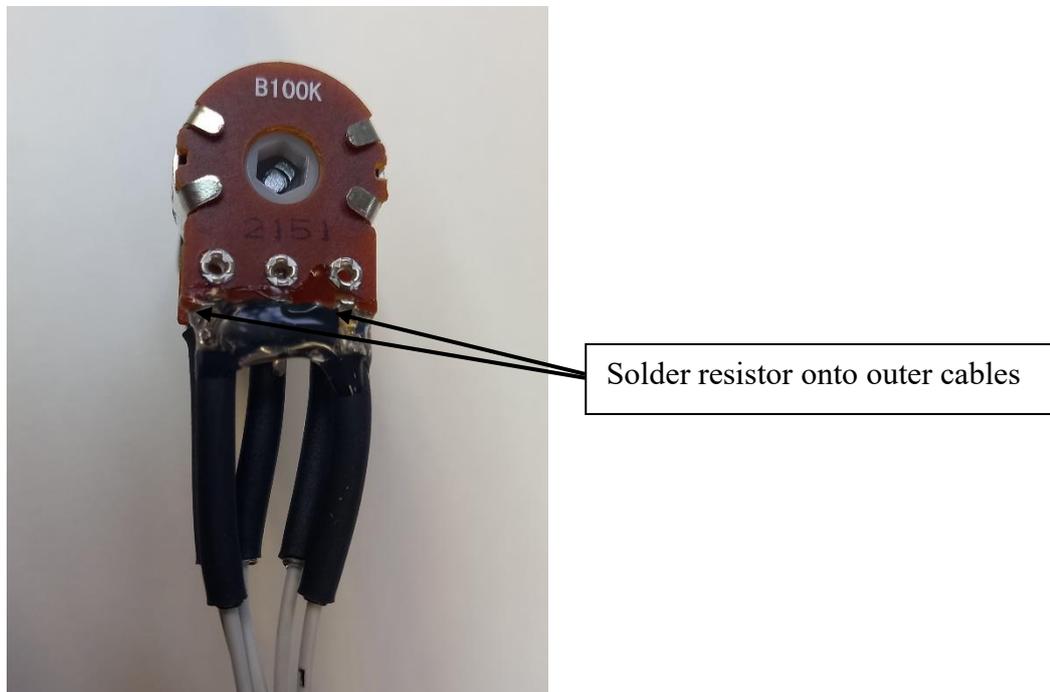
- 6.) Secure solder joints with hot glue (such as hot melt adhesive 202 from Würth), be sure that the shaft of the potentiometer is not getting in contact with hot glue.
- 7.) Re-install potentiometer, tighten the nut and put on the cap

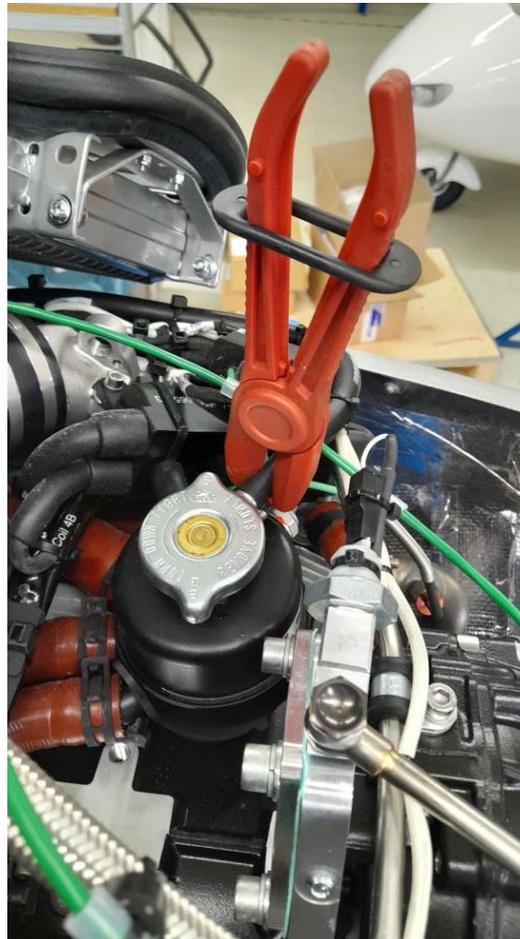
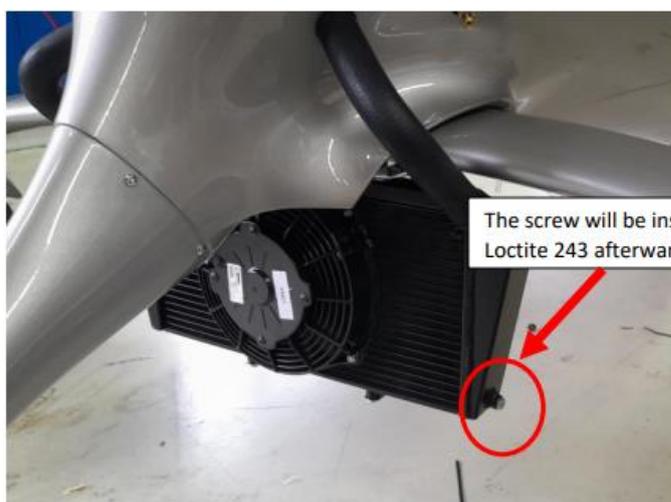
- 1) Remove the upper engine cowling according to 52-00-00 4-1 in the Maintenance Manual.
- 2) Block the coolant hose from the overflow bottle with a clamp. Drain the coolant by removing the screw at the bottom of the radiator and loosening the lid of the coolant tank.

The screw will be installed with
Loctite 243 afterwards.

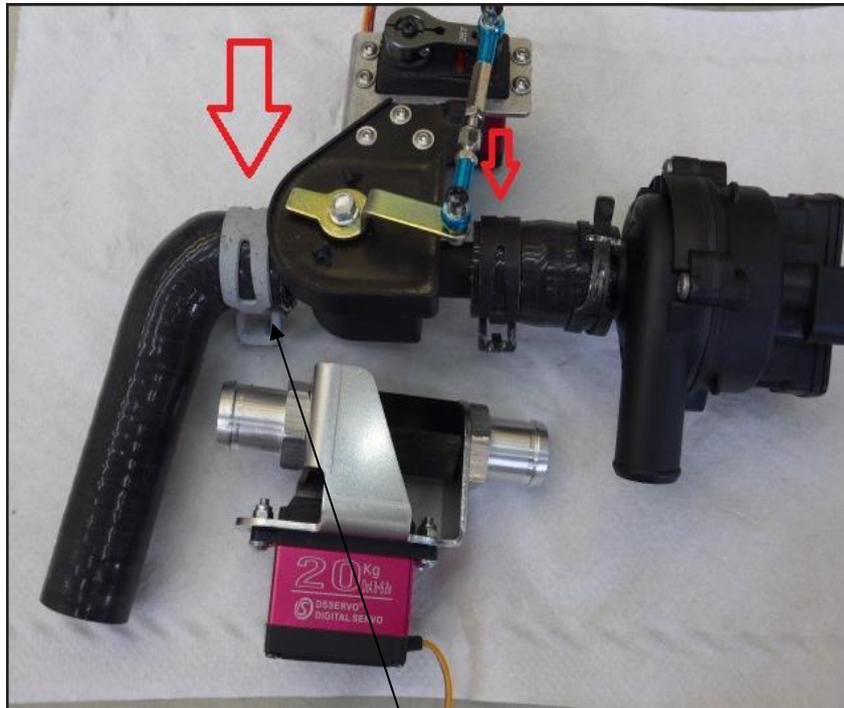
Clamp removed, hose removed from old valve unit, here to see on the left side, same on the other side with the clamp

- 3) Remove the carpet in the foot well, cover the parts there with rags to absorb the coolant and protect them.
- 4) Remove the hose clamps from the valve unit and the plug where the servo is attached.

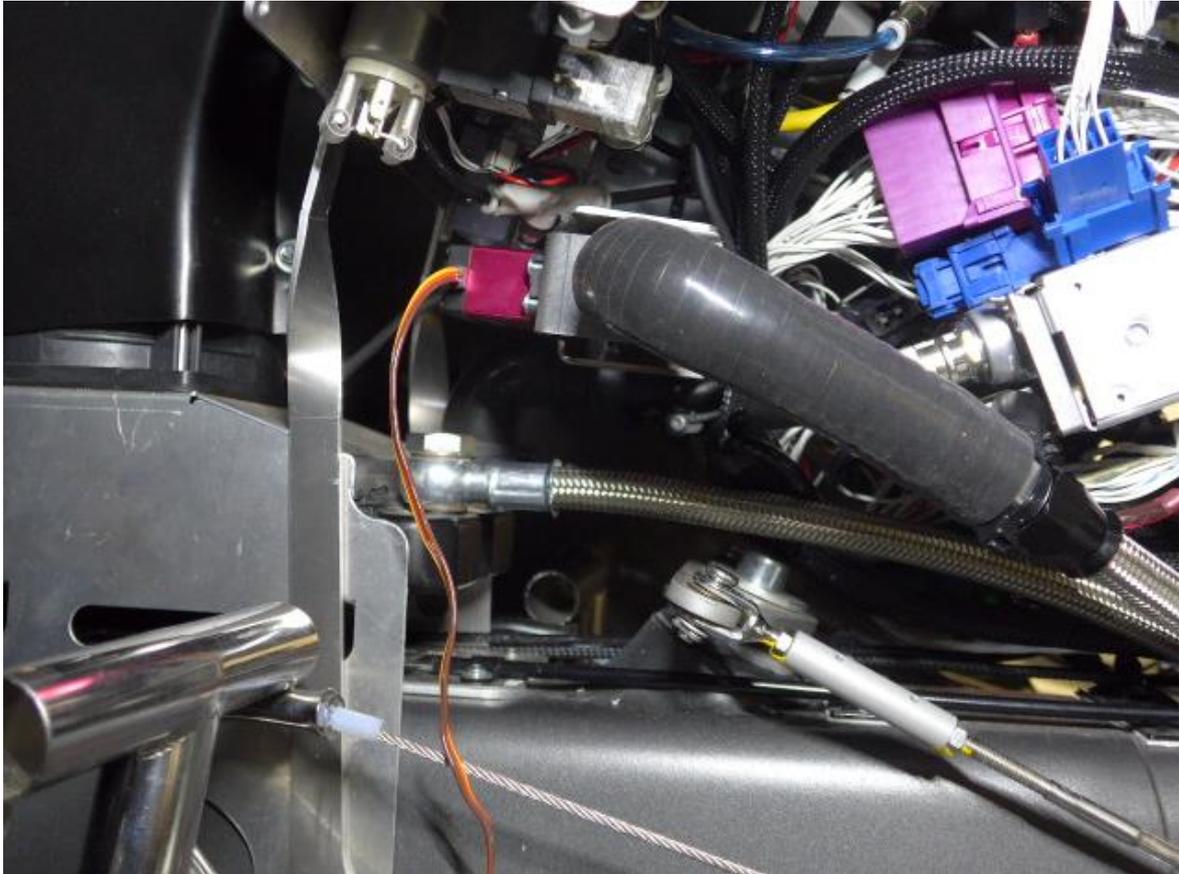
- 5) Replace the old with the new valve unit and reconnect the Servo. Before re-installing the unit a functional check of potentiometer and valve has to be performed.
- 6) Connect the new valve unit electrical cable. Turn the key switch on, ensure that the valve opens and closes proportionally to the amount that the 'Temp' rotary knob rotates
- 7) Fully rotated left; the valve should be closed. Fully rotated right, the valve should be fully open. Look down the end of the valve to see this
- 8) Turn the key switch off if satisfactory
- 9) Fit the new valve unit, making sure the hose clamps are properly positioned. See photos below
