Title: MTO2017 Rework of the body near the engine L/H		
AG-SB-2023-06-B-EN	Effective Date: 01.11.2023	Compliance Category: A – MANDATORY B – RECOMMENDED C – OPTIONAL
Applicability		
Aircraft type & model: MTO2017	Affected Serial number(s): All MTO2017 with 915 iS engine built before 2023	
The maintenance manual to be referenced is this stated or subsequent issue.		As per AutoGyro website
This form is the response from AutoGyro GmbH either against a problem found in the product in service requiring a containment or rectification action, or as service information for aircraft modification incorporation. For help, contact airworthiness@auto-gyro.com .

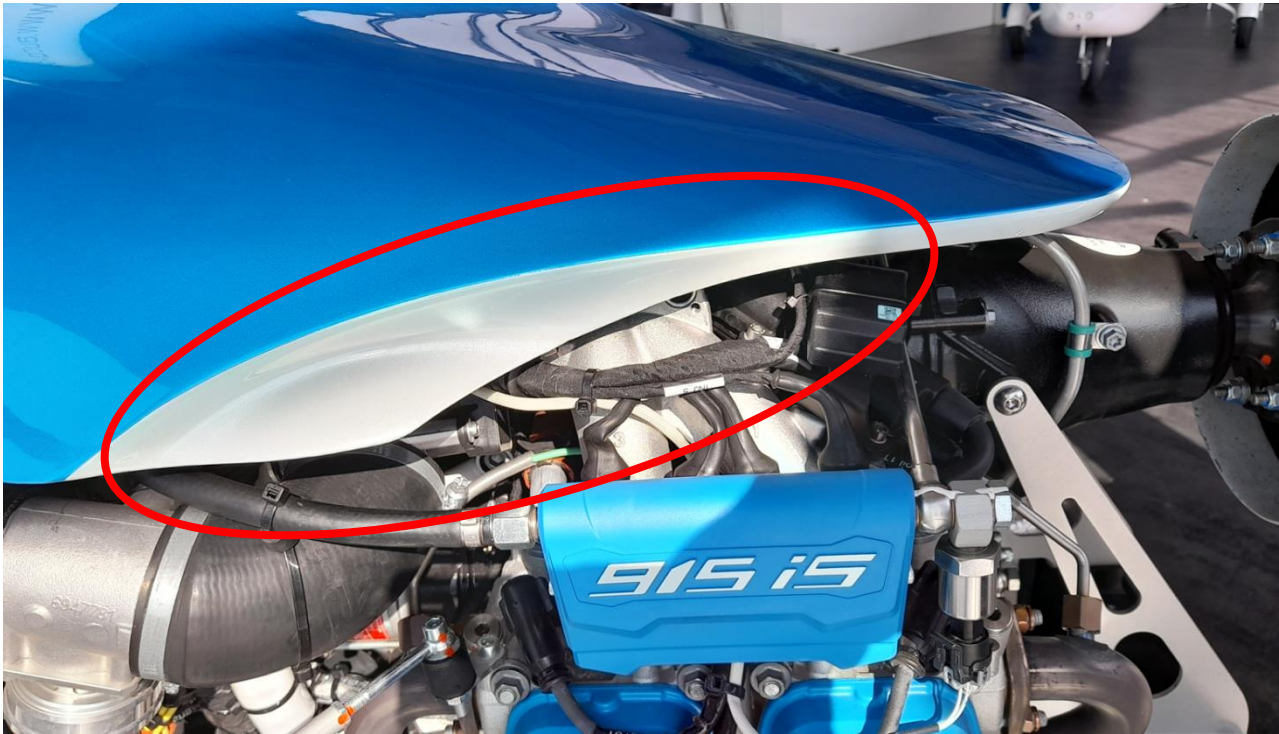
Feedback from the market has shown that certain flight and load conditions for an MTO2017 can cause a contact between the wiring harness of the left side of the engine and the body which can lead to damages of the wiring.

Old version and before rework:

Wiring harness has to be checked for damages before starting the work. Is there no damage visible rework is not necessary.

If there is some kind of damage visible either the body has to be removed for the rework or the engine has to be covered to avoid any dirt getting to the engine.

The new contour of the body must be marked. Rework the body carefully with a dremel to reach a 2cm gap between the harness and the body.

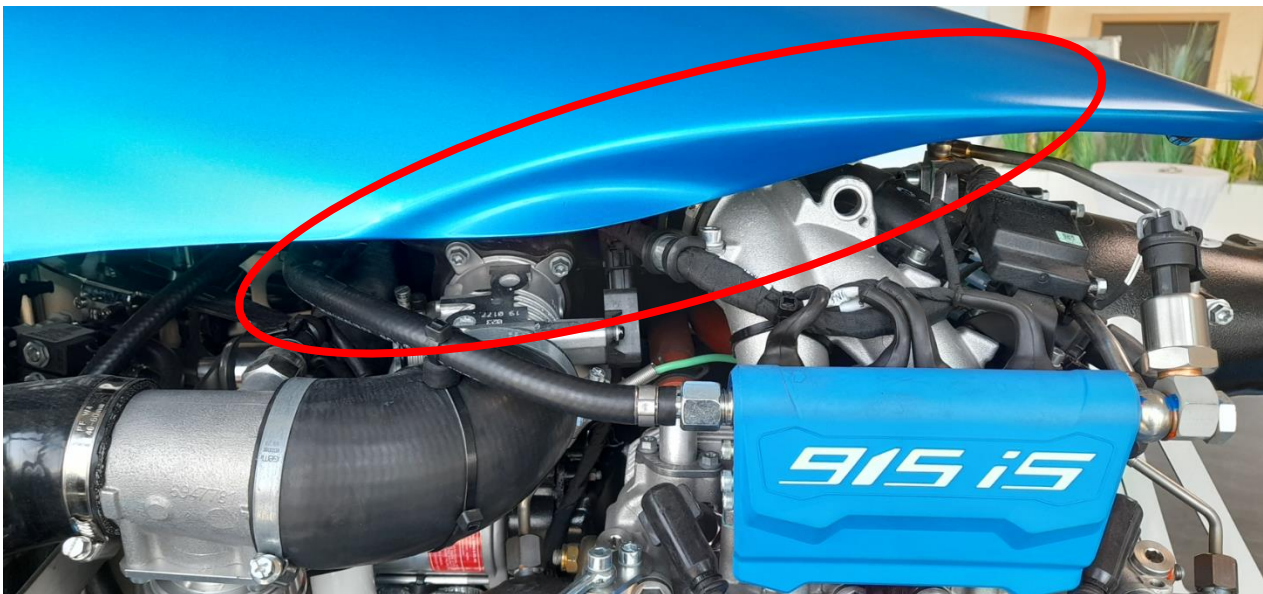
This is the contour the parts are built with now:

But it is sufficient to remove a little bit of the body to enlarge the gap to the above mentioned 2cm.
