**AG-SIL-2017-01-A-EN – Calidus frame upper mast side plate**

**Category A**

This Service Information Letter is applicable for Calidus.

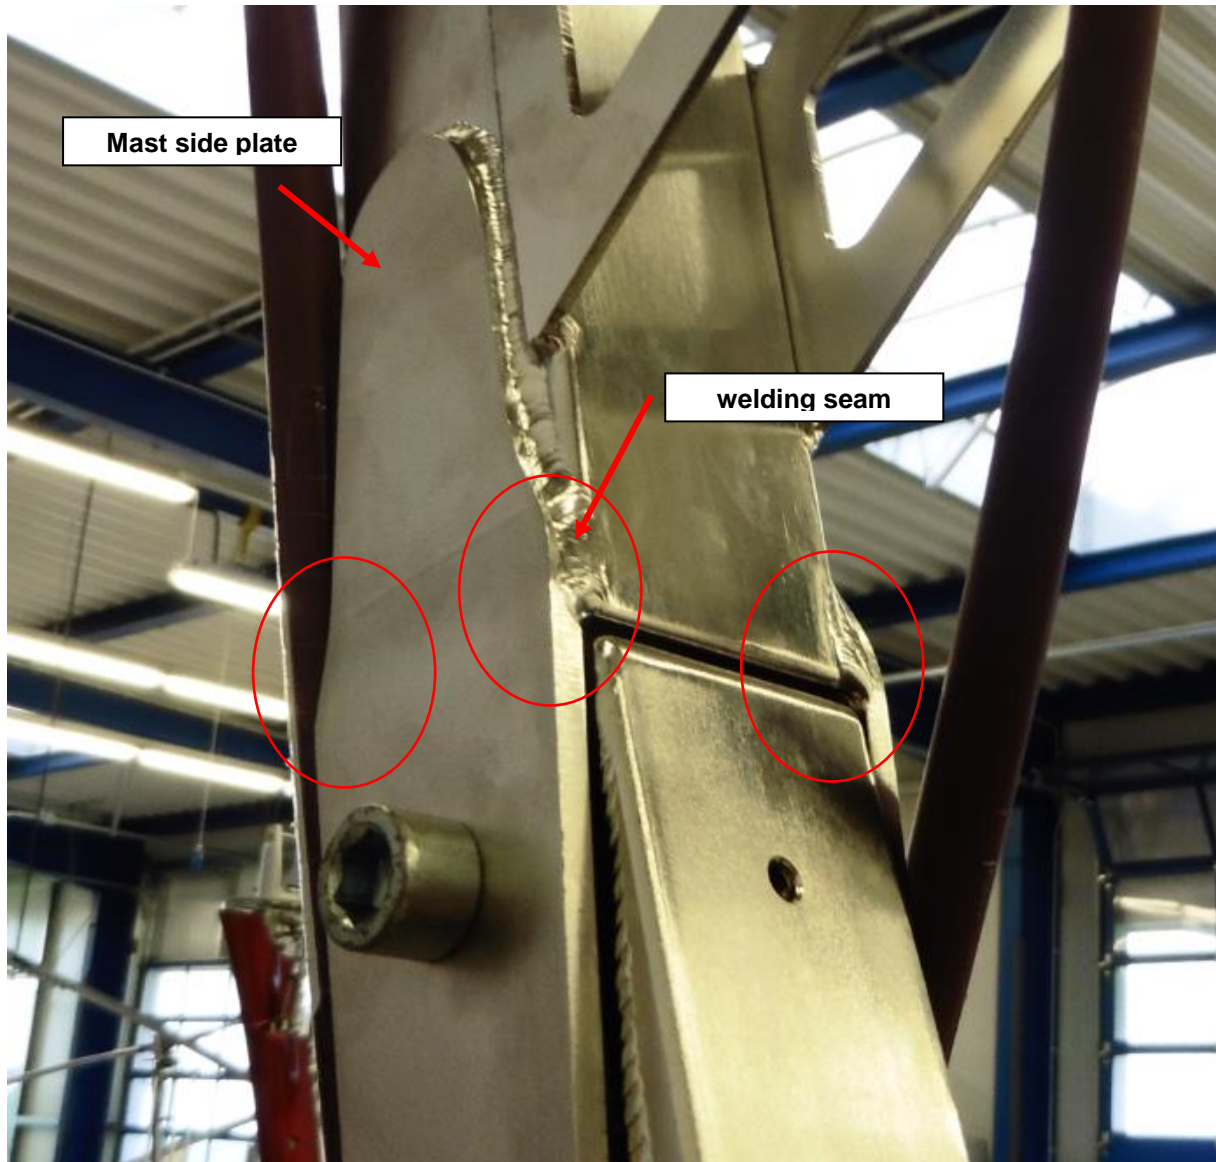
A case was found with a severe crack in the mast side plates that connect the upper mast to the lower.

The purpose of this SIL is to highlight the need to thoroughly check this part (see fig.1).

Fig 1: Calidus upper to lower mast connection new

- check the upper to lower mast side plates thoroughly for cracks (see fig. 1 and 2)
- check the weld seams of the side plates to lower mast for cracks (see fig. 1)
- Rectification: replace the main frame top, Calidus (upper mast) if cracks are found

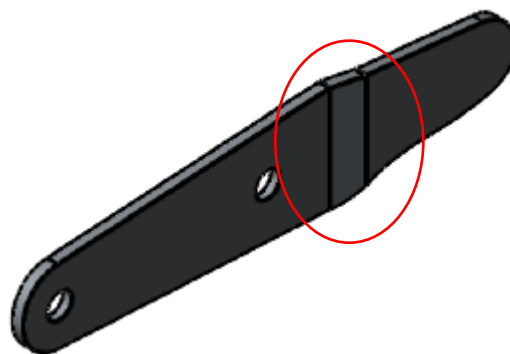
Fig 2: Calidus upper to lower mast connection old

**Check carefully here,  
4x places**

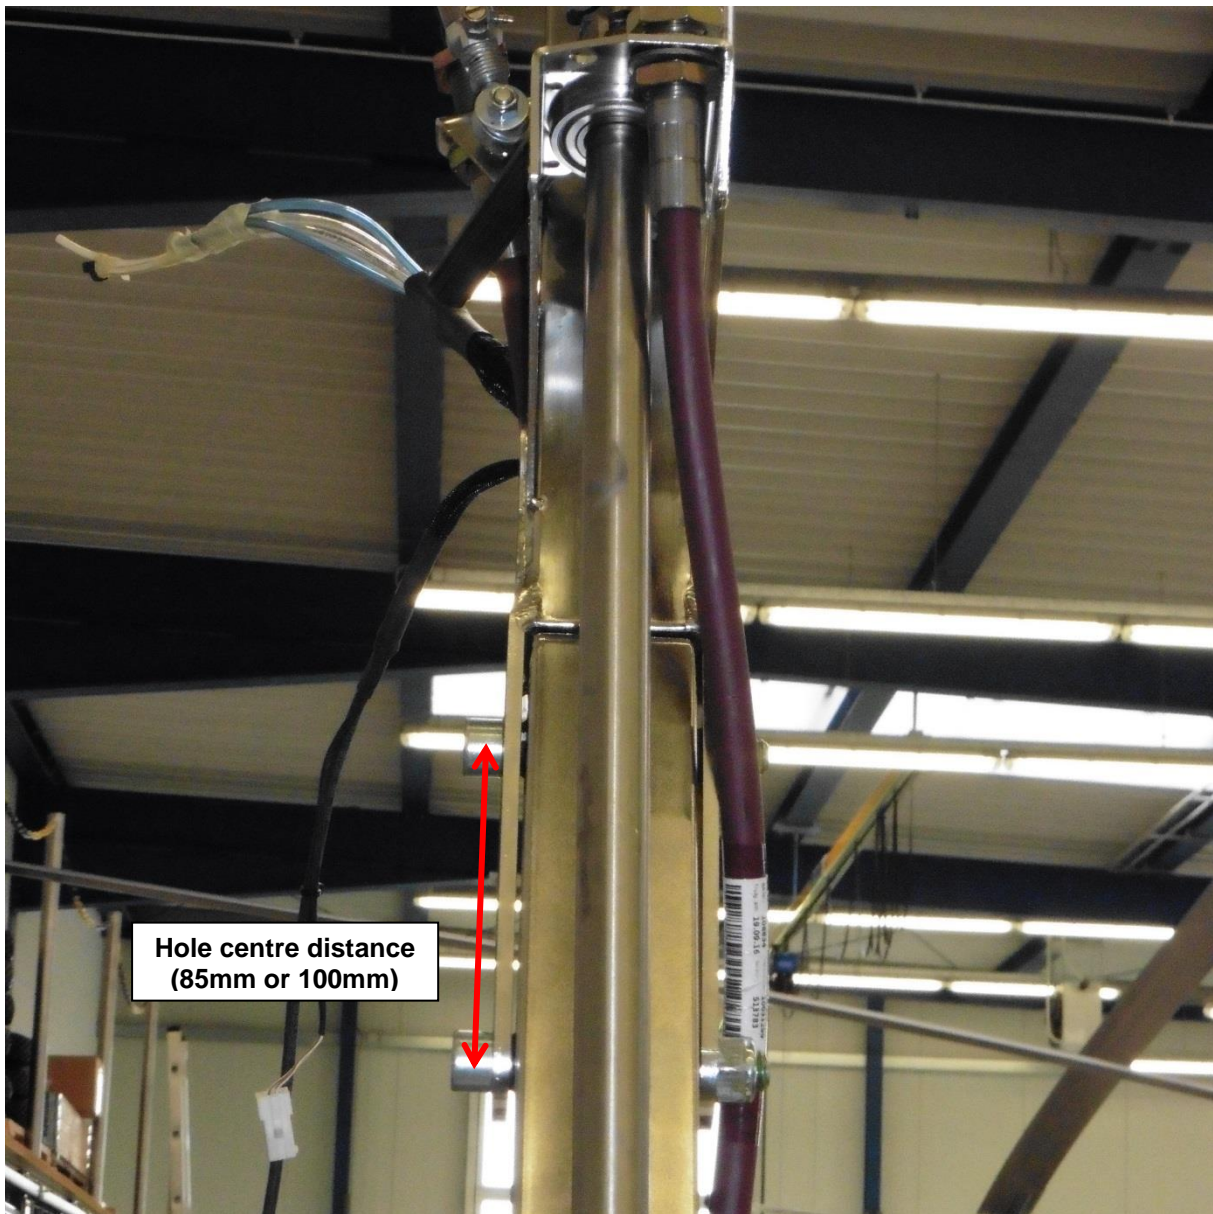
**Fig 3: Calidus upper to lower mast connection hole distance**

- 53-00-00-C-31240 (L2) Main frame top, Calidus (100mm hole distance)
- 53-00-00-C-45408 (L2) Main frame top, Calidus (85mm hole distance)
