**FLANGE BUSHINGS INSPECTION of the KW-30 PROPELLER INSTALLED in  
ROTAX 915 ENGINE**

Type / Model: **Hydraulically variable pitch propeller  
KW-30-A-H-3-0-0-F**

Manufacturer: **Woodcomp Propellers s.r.o.**

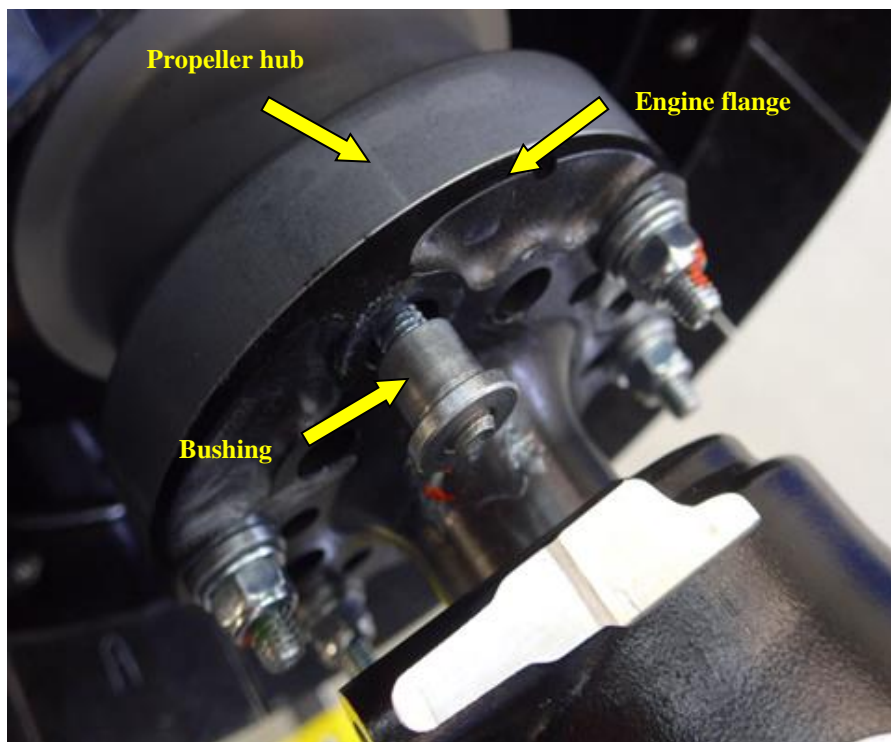
Reason  
It has been found that due to tolerances in the production of the Woodcomp assembly bushings and the engine flange, there is a possibility that the propeller may not correctly seat on the engine flange when the bushings are produced on the upper tolerance and the engine flange on the lower tolerance. This can lead to movement of the propeller on the engine propeller flange. See Fig. 1 and Fig. 2 for the situation.

Fig. 1: Bushing installation.

This service bulletin provides instructions on how to inspect and rectify the problem of negative coincidence of tolerances.

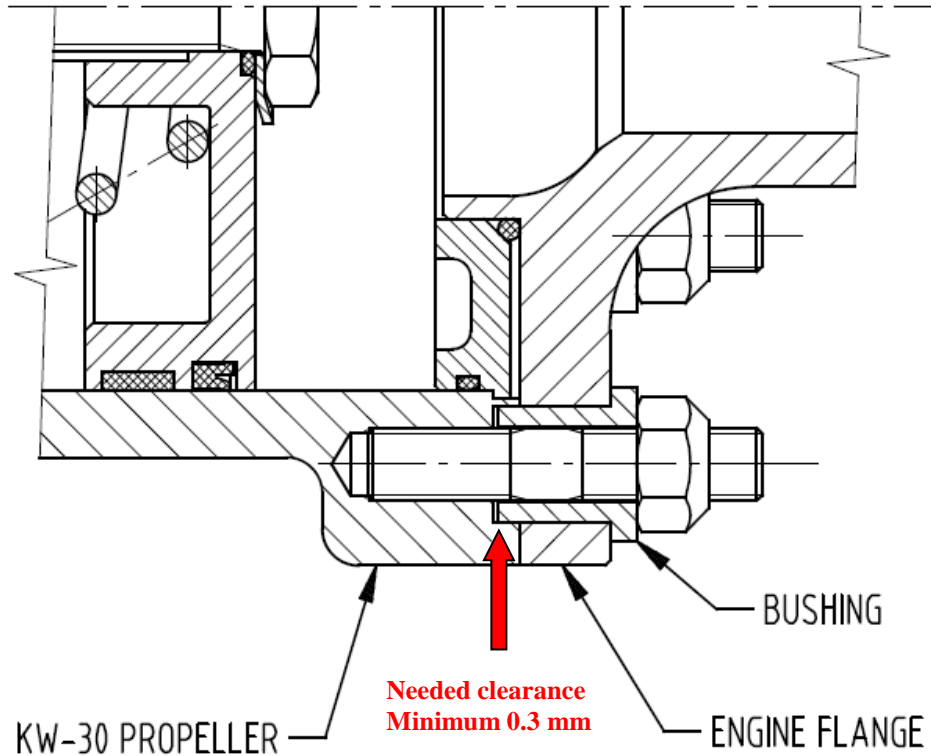
Fig. 2: Requested minimum clearance 0.3 mm

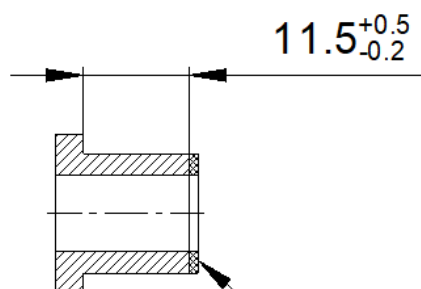
**REMOVE MATERIAL  
HERE**

Fig. 3: Bushings rework

<p>Manpower estimates</p>	<p>The task may only be performed by an organization or individual entitled and trained to carry out maintenance on the aircraft. Estimated man-hours to complete the task as a stand-alone item is: 1.0 – 2.0 hrs</p>
<p>Compliance</p>	<p>This bulletin should be complied with <b>before next flight!</b></p>
<p>Work procedure</p>	<ol style="list-style-type: none"> <li>1. Ensure the wheel brakes are applied and the mag switches/ignition are switched in the "off" position.</li> <li>2. Remove the propeller spinner.</li> <li>3. Remove the 6 nuts and washers securing the propeller to the propeller gearbox flange.</li> <li>4. Place a container under the propeller gearbox flange (a small amount of oil will escape from the flange shaft when the propeller is removed). Carefully remove the propeller.</li> <li>5. Remove the bushings from the engine flange.</li> <li>6. Shorten the bushings according to the Fig. 3.</li> <li>7. Re-assemble the propeller in accordance with the Woodcomp UM-06 User Manual, tightening the nuts to 22Nm.</li> <li>8. Once assembled, ensure there is no movement of the threads or bushes evident in the propeller flange discernible when applying force to the propeller assembly laterally and vertically.</li> <li>9. Carry out a ground run of the aircraft for correct function and security of the propeller.</li> <li>10. Carry out a check-torque of the 6 propeller assembly nuts post ground run. Mark the threads and nuts with torque seal if required (country of registration dependent).</li> <li>11. Check the engine oil level post ground run and top up if required.</li> </ol>

<p>Accomplishment instructions</p>	<p>Effective date of this SB is 30 April 2020.</p> <p>All work is to be carried out in accordance with the latest model-relevant Aircraft Maintenance Manual, and the latest Woodcomp TN-30 0 EN 100-hours inspection KW-30 Maintenance manual.</p> <p>In case of need contact the propeller manufacturer Woodcomp Propellers s.r.o. Phone: +420 283 971 309 Fax: +420 283 970 286 E-mail: info@woodcomp.cz</p>
<p>Work to be performed</p>	<p>By service organization authorized by the aircraft manufacturer</p>
<p>Costs borne by</p>	<p>Operator</p>
<p>Tooling required</p>	<p>Standard tools</p>
<p>Material necessary</p>	<p>Rubber sealing O-ring 45x2 PN 029281.2, one piece. Self- locking nuts M8, six pieces. In case of need the rework of the bushings can be done by Woodcomp Propellers s.r.o. and the bushings together with nuts and O-ring will be sent to the propeller owner free of charge.</p>
