Title: Door adjustment Cavalon		
AG-SIL-2024-03-EN		Released: 1 st of September 2024
Applicability		
Aircraft type & model: Cavalon	Affected Serial number(s): All	
The maintenance manual to be referenced is this stated or subsequent issue.		As per AutoGyro website
<p>This form is the response from AutoGyro GmbH either against a problem found in the product in service requiring a containment or rectification action, or as service information for aircraft modification incorporation.</p> <p>For help, contact AutoGyro, email: airworthiness@auto-gyro.com.</p>

Reason and overview of the Service Information Letter

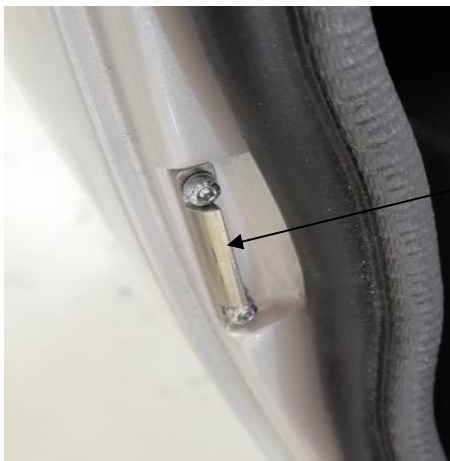
Check for grease

Always check if there is a little bit of grease, vibrations and parts without grease can cause the door opening

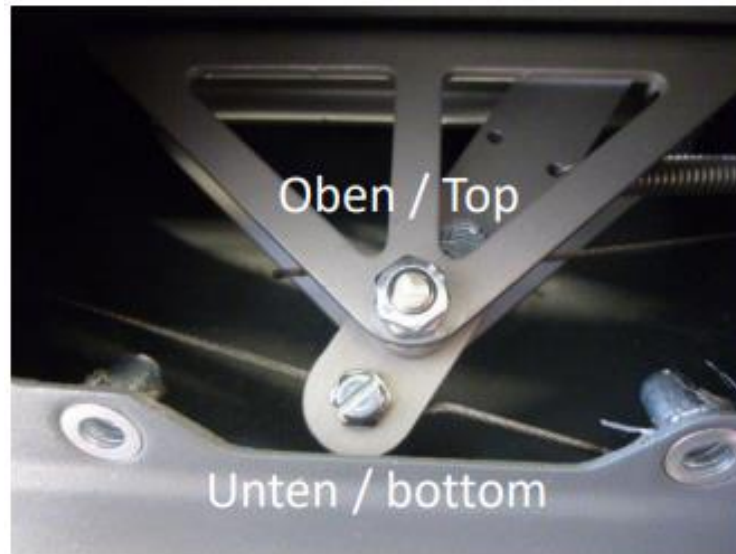
Top = latch pin cable assy (snapper) short
 Bottom = latch pin cable assy (snapper) long

1. Open the maintenance cover on the bottom of the door. Access is then possible to the two latch pin cables.
