Title: Exchange Of Antenna Wire		
AG-SB-2025-02-B-EN	Effective Date: 25.07.2025	Compliance Category:
Applicability		A – MANDATORY B – RECOMMENDED C – OPTIONAL
Aircraft type & model: AutoGyro Calidus AutoGyro Cavalon	Affected Serial number(s): Depending on equipment see “Reason and Overview”	
The maintenance manual to be referenced is this stated or subsequent issue.		As per AutoGyro website
<p>This form is the response from AutoGyro GmbH either against a problem found in the product in service requiring a containment or rectification action, or as service information for aircraft modification incorporation. For help, contact airworthiness@auto-gyro.com.</p>

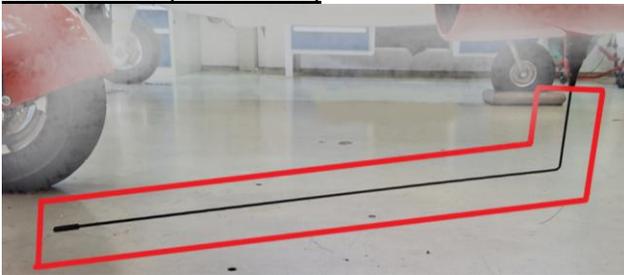
Old version: (Black wire)

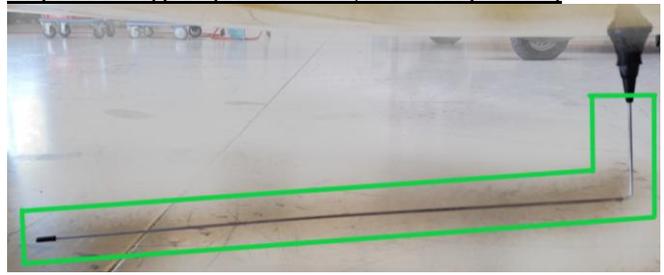
Improved type: (silver wire, if factory fitted)

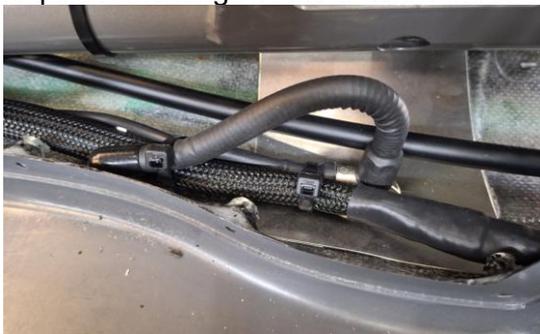
Calidus

1. Remove controls cover (ref. JobCard 52-40-00 2-1)
2. Pictured is the affected antenna, which requires exchange of the antenna wire.

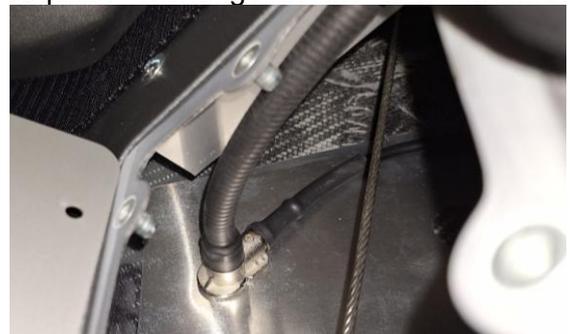
Cavalon

1. Remove cover below right-hand control stick (ref. JobCard 52-40-00 0-1)
2. Pictured is the affected antenna, which requires exchange of the antenna wire.
