AG-SB-2023-01-C-EN	Effective Date: 01.04.2023	Compliance Category:
Applicability		A - MANDATORY
Aircraft type & model:	Affected Serial number(s):	B - RECOMMENDED
MTO2017	All MTO2017 produced before 07/2021	C - OPTIONAL
The maintenance manual to be referenced is this stated or subsequent issue.		As per AutoGyro website

### Reason and overview of the Service Bulletin (cause of problem if known)

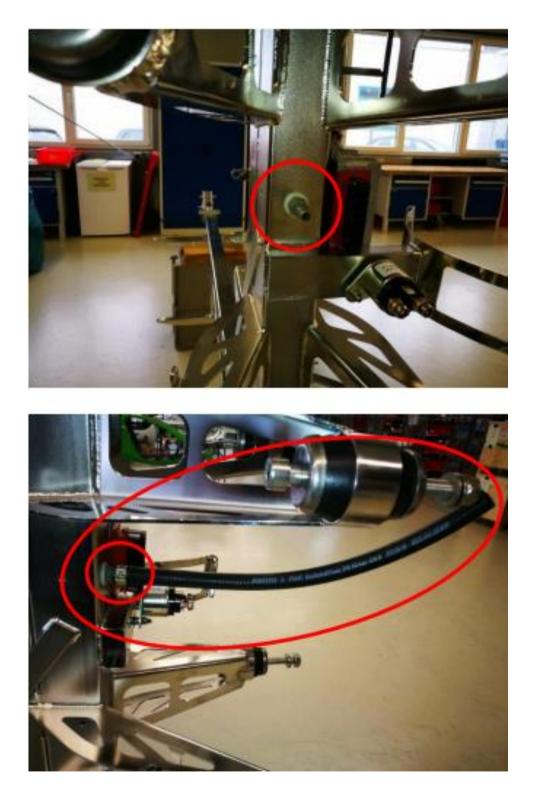
The oil breather hose is connected from the top of the oil tank into the stainless steel frame of the aircraft. The oil vapour of the engine should go overboard via the frame below the aircraft. Due to the fact that the frame has several openings in different places, it has been found in service that, in some circumstances, the oil vapour may be vented such that the occupants notice an oil smell.

Old version of oil breather hose routing:

This situation has been improved by extending the oil vent hose such that it leads directly to the lower end of the airframe cell where the oil vapour is blown away beneath the aircraft.
