Title: Cavalon (Rotorhead III) & MTO2017 Pitch Trim Pressure Correction		
AG-SB-2019-02-B-EN		Compliance Category:
Applicability		A - MANDATORY B - RECOMMENDED C - OPTIONAL
Aircraft type & model: Cavalon & MTO2017 with Rotorhead III	Affected Serial number(s): All Cavalon from V00349 to V00405 & all MTO2017 to M01810 (Rotorhead III)	
The maintenance manual to be referenced is this stated or subsequent issue.		As per AutoGyro website
This form is the response from AutoGyro GmbH either against a problem found in the product in service requiring a containment or rectification action, or as service information for aircraft modification incorporation. For help, contact AutoGyro on 49(0)5121 88056-00, or email airworthiness@auto-gyro.com .

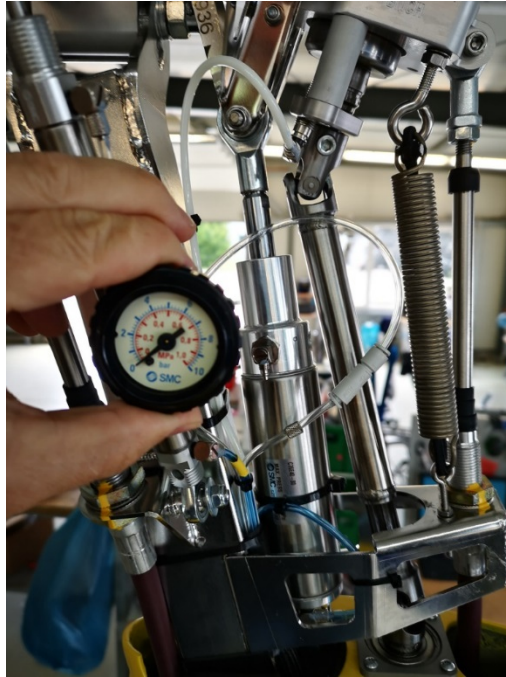
1. Remove the upper pneumatic connection (clear hose) of the brake/trim cylinder and attach a manometer with a non-return valve (Pic.1)
2. Unhook the rotor bag from the nose and ensure the rotor is able to pitch rearwards under control (a second person holding the bag chord).
3. Switch the flight/brake switch to flight, ensure the propeller is clear of obstruction and turn on the ignition.
4. Apply nose up trim by moving the 4-way switch on the top of the stick to the rear.
5. Note the maximum pressure reading on the manometer. If it is 8 bar then no further action is required. Reconnect the upper brake/trim cylinder pneumatic hose and mark with mechanic paint.
6. If the pressure is more than 0.25 bar less than that displayed in the cockpit then carry out steps 7-13:

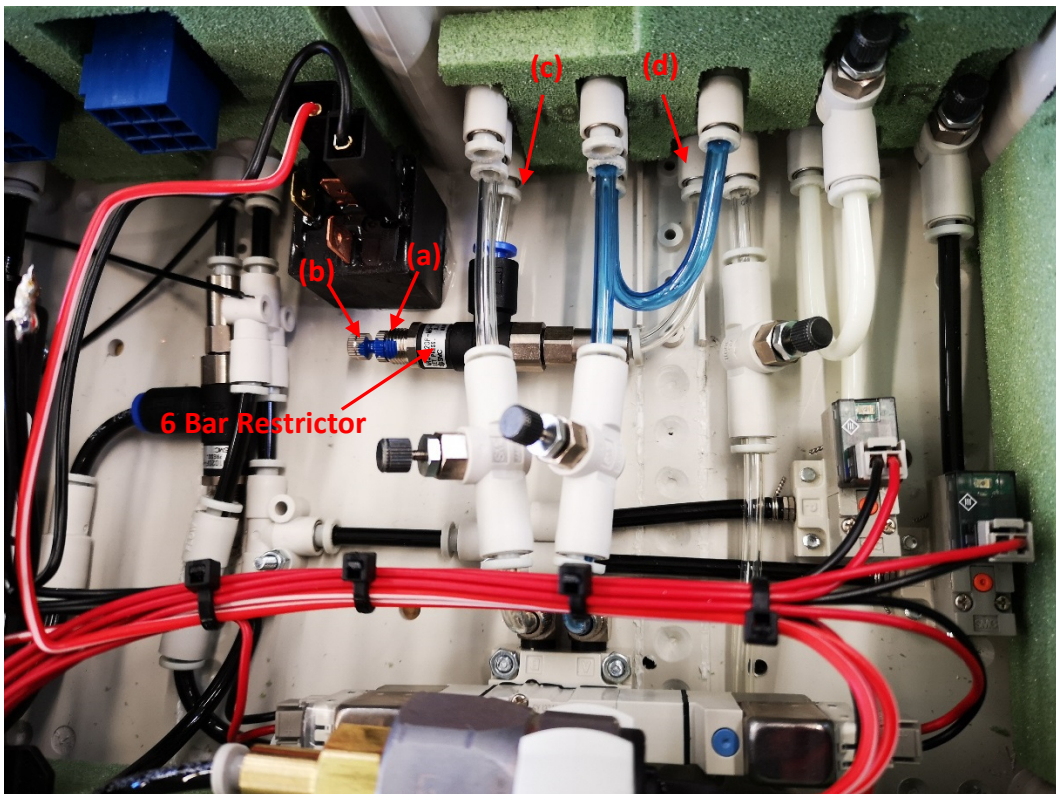
(Pic.2)

7. Gain access to the 6 bar pressure restrictor (pic.2) by removing the cover of the pneumatic box (in the nose area behind the cockpit of the Cavalon 915, behind the engine bay firewall in the Cavalon 914, or in the nose compartment of the MTO2017 – 6 screws).
WARNING: If the box has the heating option fitted then the elements are attached to the lid and must be disconnected from the box at the black 3 pin connector.

8. **Either:** release the lock-nut of the adjustment knob of the restrictor (a) and screw the adjustment knob (b) in until 8 bar can be obtained in steps 1-5 above. Re-lock the lock-nut and mark with mechanic paint.

9. **Or the preferred solution:** remove the restrictor and connecting hoses at points (c) and (d) (pic.2) and replace with a single piece of clear pneumatic hose of approx. 130mm length (pic.3).

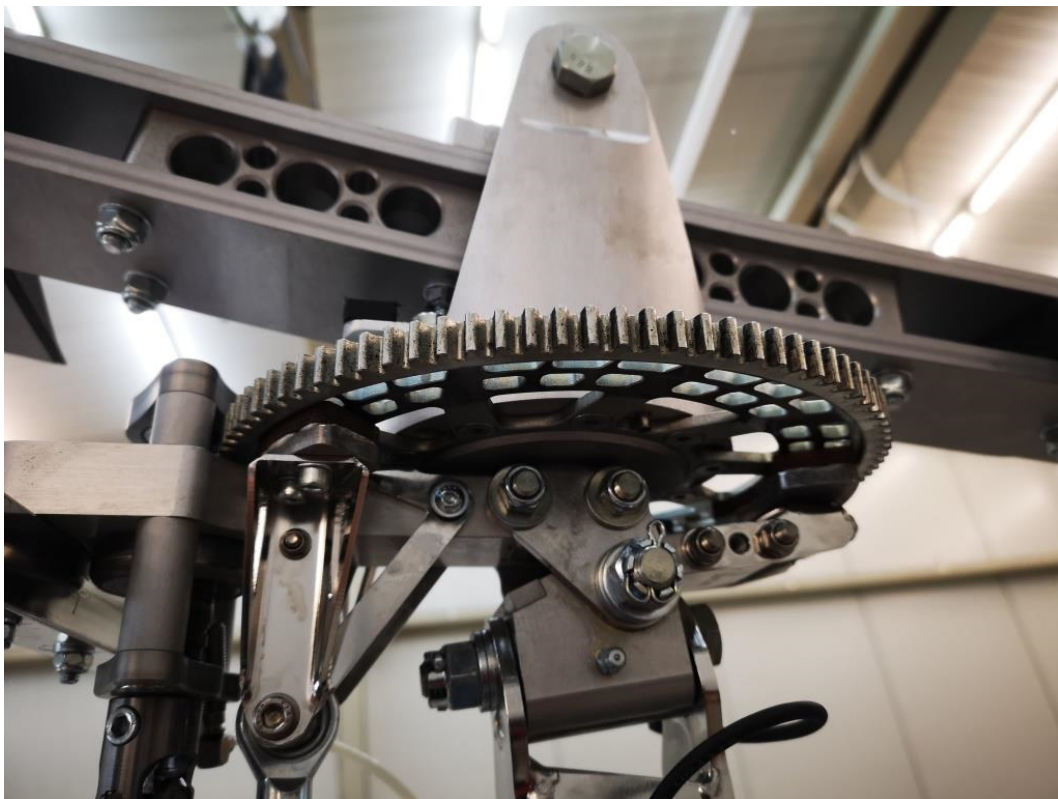
Aircraft fitted with Rotorhead III (see photos) have a shorter distance between the rotorhead pitch axis and trim cylinder attachment, such that a higher trim cylinder pressure results in the same hand force on the stick.
