Title: Calidus Rotor Head II to III Upgrade		
AG-SB-2023-03-C-EN	Effective Date: 15.10.2023	Compliance Category: A - MANDATORY B - RECOMMENDED C - OPTIONAL
Applicability		
Aircraft type & model: AutoGyro Calidus	Affected Serial number(s): Calidus fitted with Rotor Head II	
The maintenance manual to be referenced is this stated or subsequent issue.		As per AutoGyro website
This form is the response from AutoGyro GmbH either against a problem found in the product in service requiring a containment or rectification action, or as service information for aircraft modification incorporation. For help, contact airworthiness@auto-gyro.com .

Reason and overview of the Service Bulletin (cause of problem if known)

The AutoGyro Calidus has been produced with rotor head III as standard since April 2018. AutoGyro has developed a rotor head II to III modification set (46040) and are now able to offer this as an upgrade option to customers of Calidus with rotor head II.

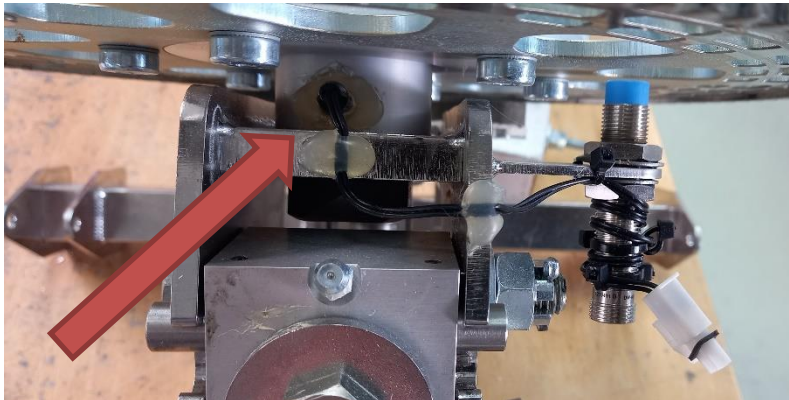
- 1.) Remove the Rotor system from the Rotor head according to job card 62-11-00 4-1 (Removal: Rotor – Teetering Parts) step 1-9. Disconnect the temperature sensor and carefully take it out of its bearing. The temperature sensor is retained with hot melt adhesive, which may be removed with a heat gun or knife. It will be used as outside temperature sensor with rotor head III.

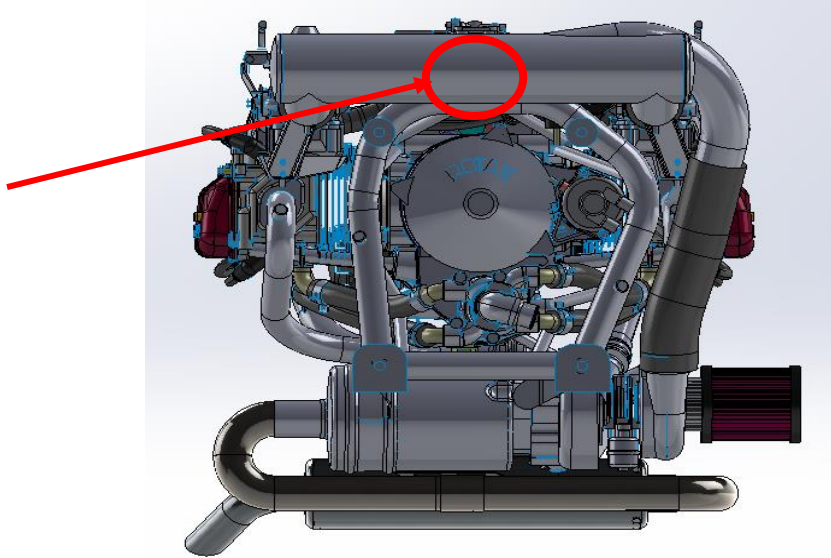
- 2.) Remove forward and after mast and all engine cover as described in job card 52-00-00 4-1 (Removal-Installation: Cowlings).
- 3.) Replace the coupling with a coupling IV.1 according to job card 63-11-10 4-1. Be aware that the airbox in the Rotax 914 has to be modified for the coupling to fit in.

Remove the airbox and carefully create a 5-10mm deep indentation of around 30mm diameter into the airbox to create a gap between airbox and vertical pre rotator coupling shaft. Refit the airbox.

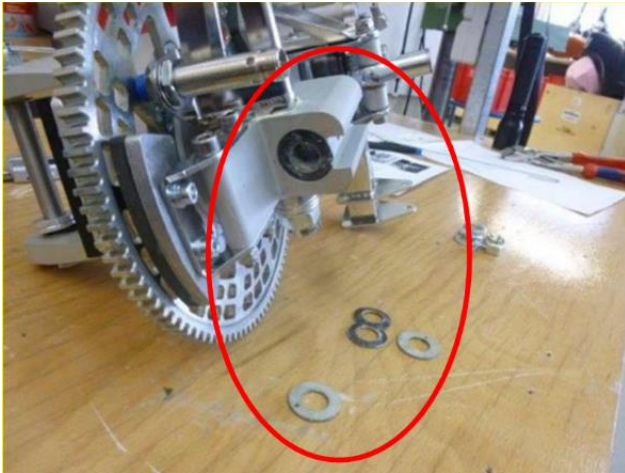
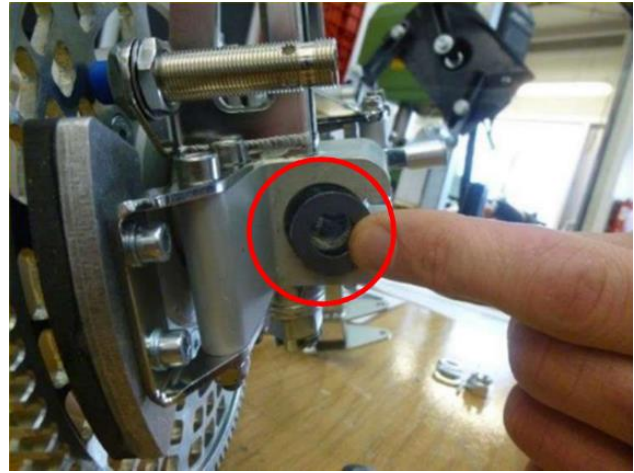
Insert 2x disc springs (convex side outwards) + shim into the front and rear rotor head as shown.

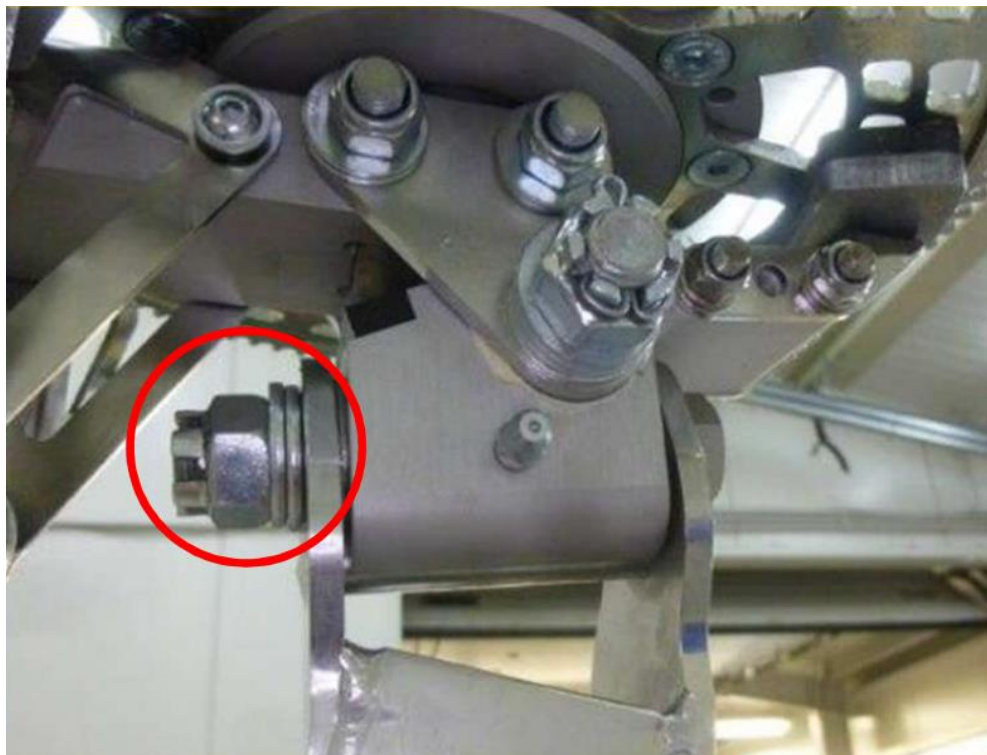
Assemble the rotor head to the mast making sure that all washers are in place and secure using the gimbal bolt + U13. Fit the castle nut M12 and 2x washer U13 as shown.

Caution: The forward U13 under the bolt head must not lie on the welding seam!

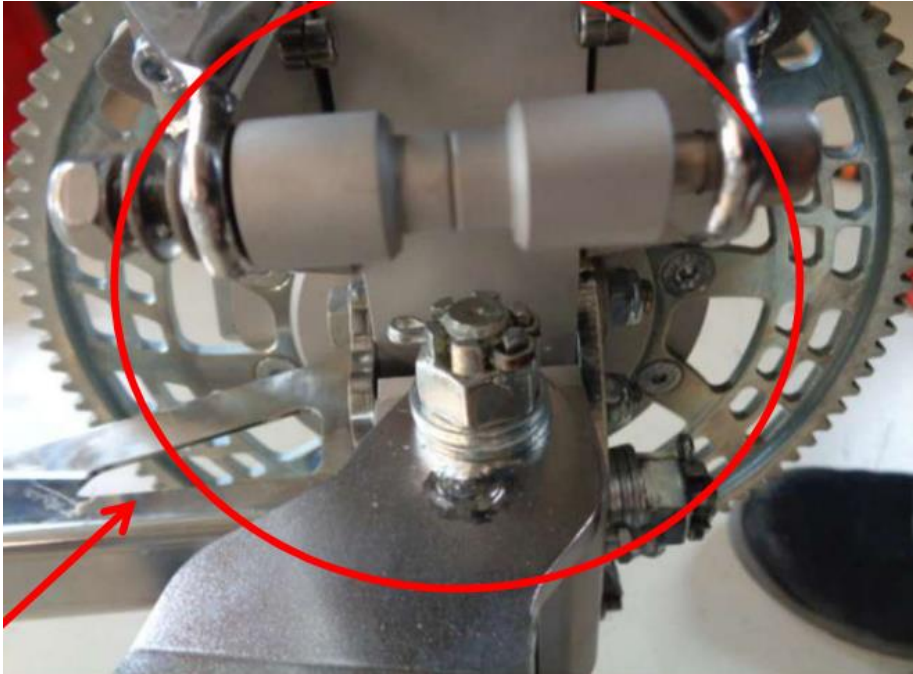
Tighten the castle nut M12 until the rotor head is no longer able to pivot. Loosen the castle nut M12 so there is a light resistance to pivoting, and the split-pin hole is aligned. If both of these conditions cannot be met, (i.e. Resistance with split-pin hole aligned) replace the castle nut M12 or use a suitable shim between the nut and the washer. Insert the split-pin horizontally and shorten the protruding legs to approx. 10mm and bend and secure as shown.

Caution: The castle nut must be in a position that it is possible to insert the split-pin lightly by hand!

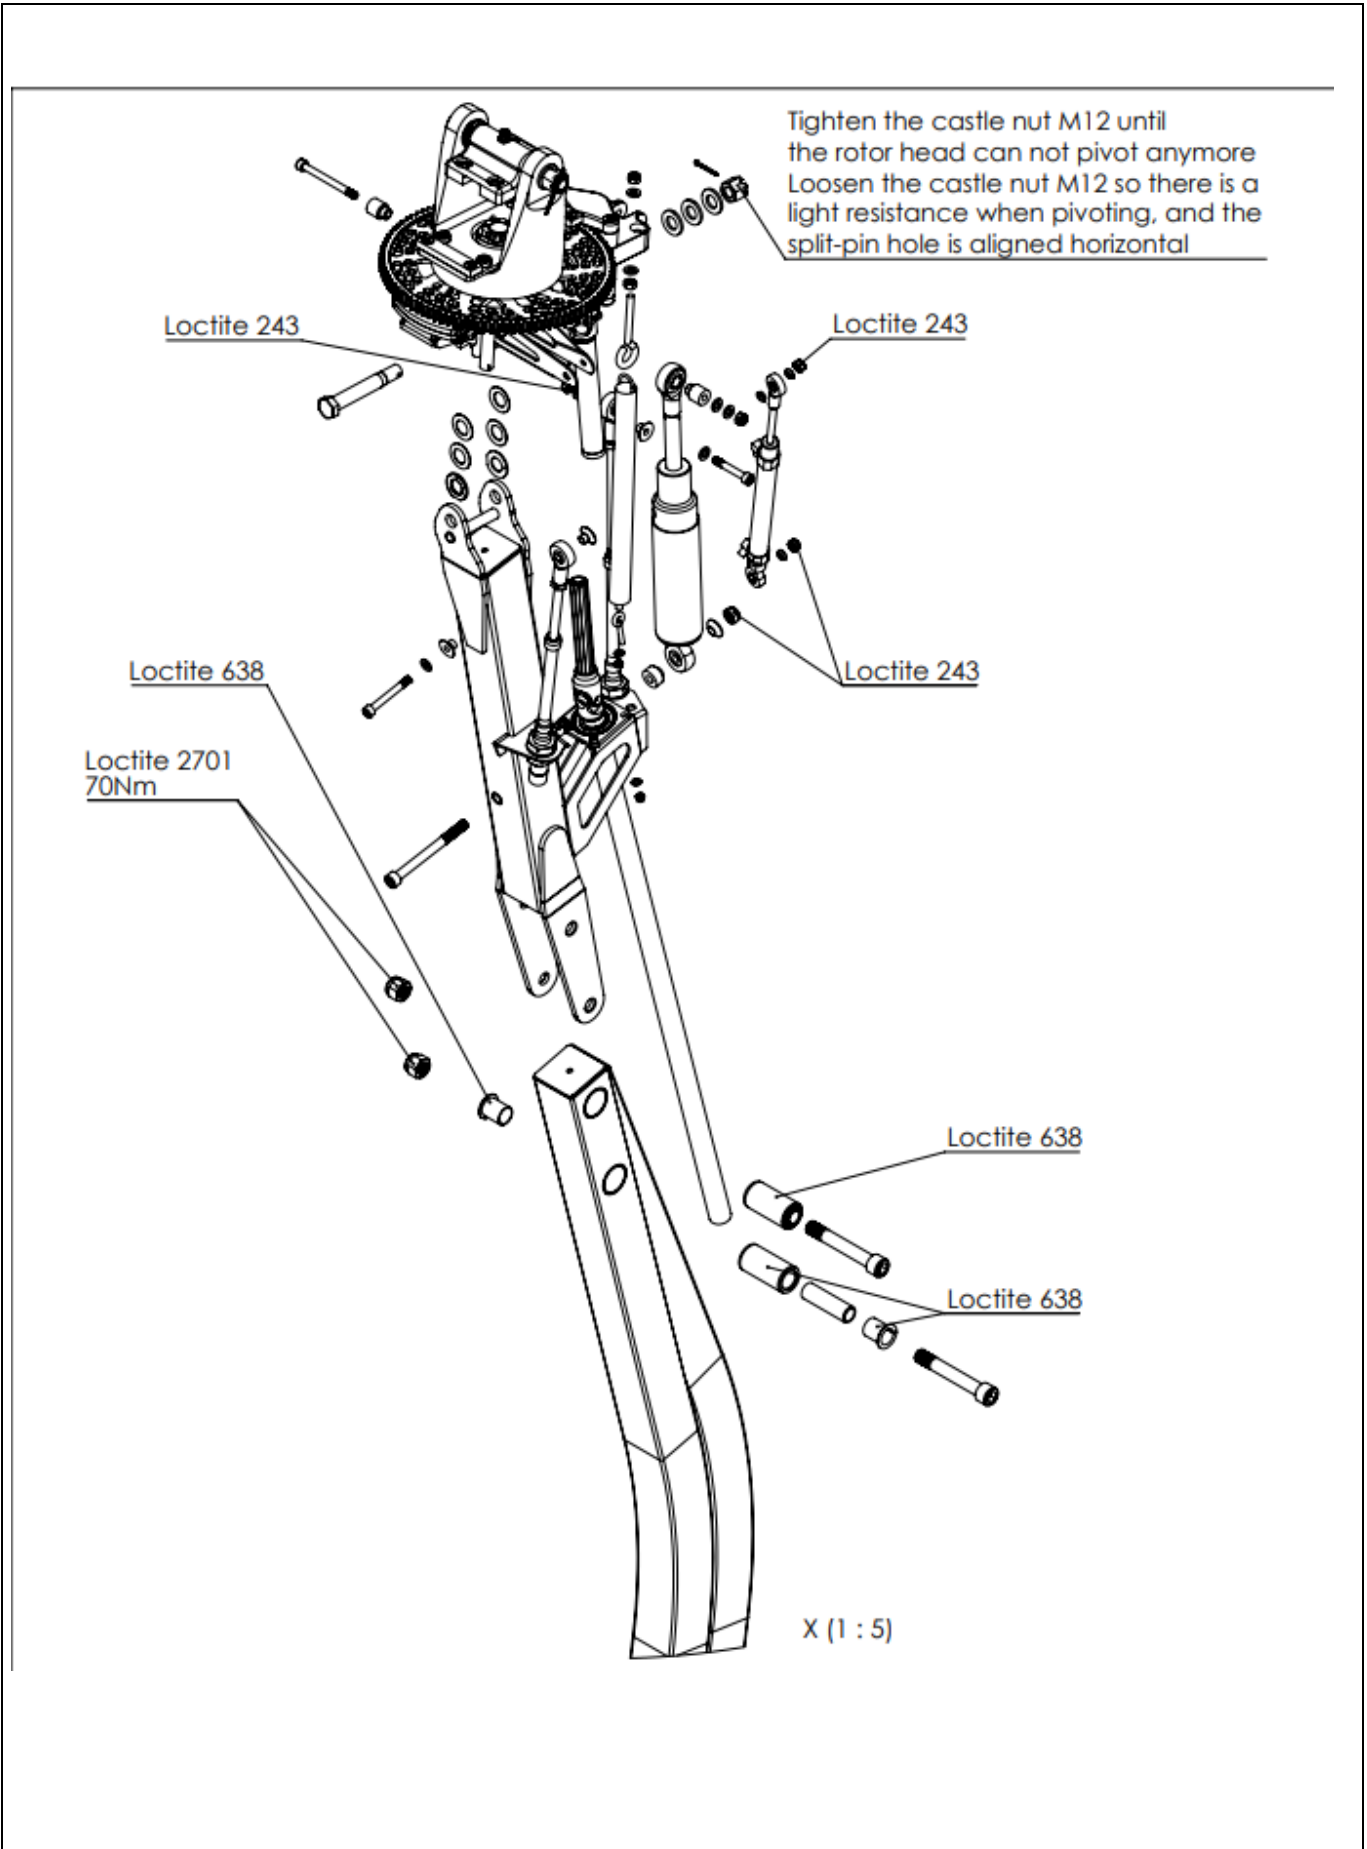
Attach the grease gun to the grease nipples at the side/front and pump into the gimbal/bolt cavity until resistance is felt in the grease gun. Remove surplus Silicon grease Lagermeister 2002.

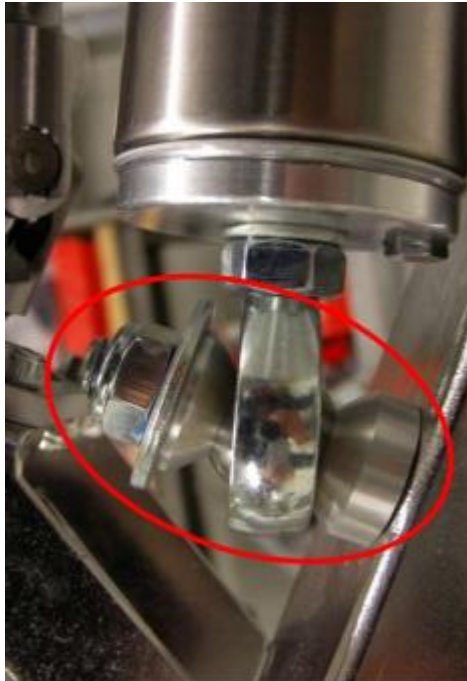
Assemble the brake / trim cylinder to the mast, using M8 70/18 and insert from front to rear, spacer 18-9/8 F + eye-end pneumatic cylinder + spacer 18-5,2/8 F + U8/24 washer + M8 Nyloc as shown.

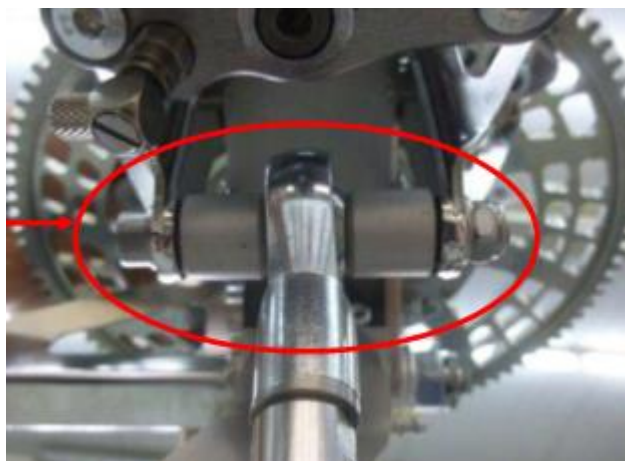
46039 – rotor head III 21,5 • Assemble the upper attachment of the brake / trim cylinder to the rotor head using M6 56/10 A4-80 + 2x spacer and 2x U6 A.

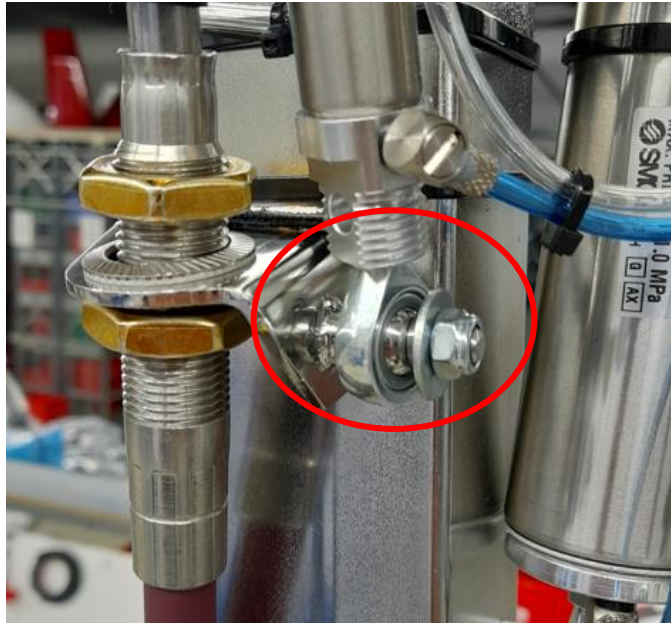
Assemble the roll-trim cylinder to the M6 attachment point at the mast as shown using spacers (angle towards rod end) and secure using U6/18 + M6 Nyloc and Loctite 243. Check clearance between bottom rod end and U6/18, if there is contact / blockage insert a further U6 washer.

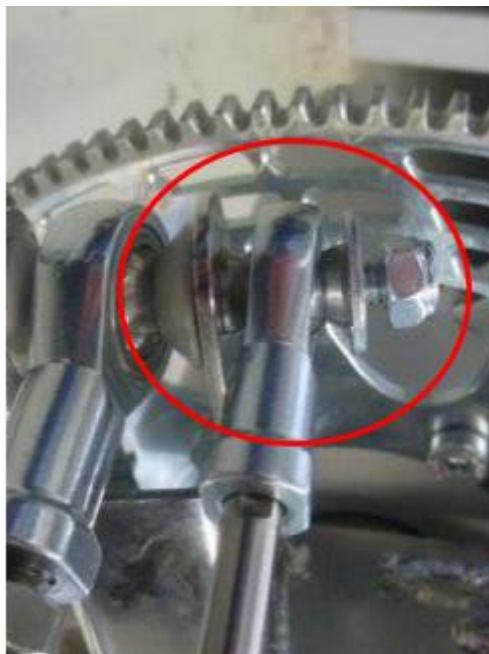
Assemble the roll/trim cylinder to the previously inserted bolt using spacers (angles facing rod end) as shown and secure using U6/18 + M6 Si • Move the rotor head through its full range and ensure there is no blockage of the roll / trim cylinder. If necessary insert a further U6 between PPC roll mounting bracket and inner spacer as shown.

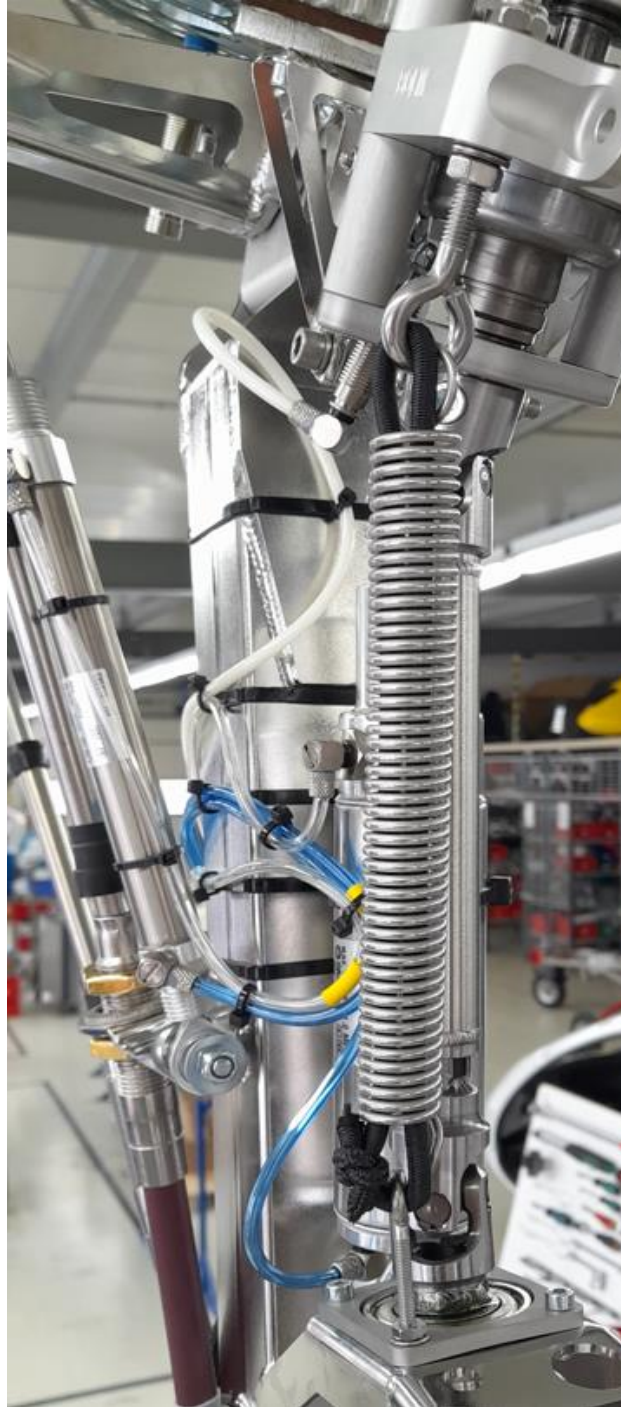
- 9.) Install the rear trim spring assembly as seen in the pictures.
NOTE! Fitment of the trim spring is optional.

The spring should be assembled so that there is light tension in the spring and rubber retaining bungee when the head is fully to the rear.

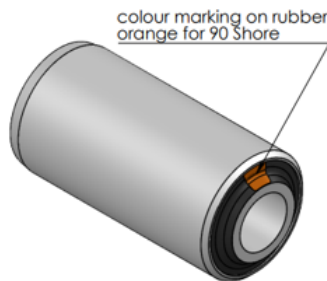
- 10.) Install the mast back on the aircraft as described in job card 62-51-00 8-1, step 12 - 24. Be aware that there has been a change which is not implemented in the Aircraft maintenance manual. The rubber bushing, 90 shore with PN 11082 will be installed in the upper mast attachment. Also check the extension of the PPC in the pictures.

Rubber bushing, 90 shore, PN 11082 for the upper mast attachment for the Calidus.

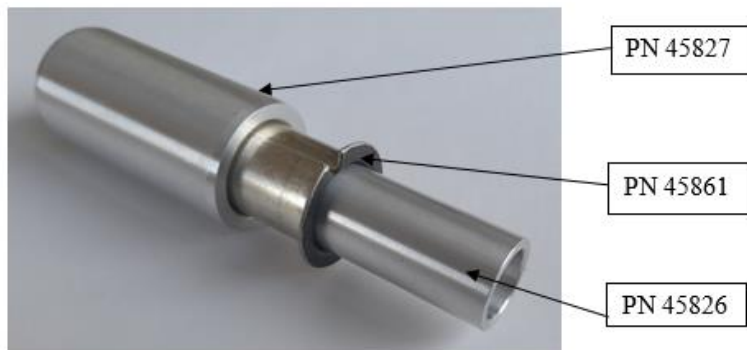
The lower attachment consists of PN 45826, PN 45861 and PN 45827

Be aware that the rubber bushing and the metal bushing are glued into the upper mast. This can be seen on the drawing on page 6. Holes in the mast and surfaces of the bushing needs to be cleaned and sanded. Don't use brake cleaner for cleaning the parts (AG-SIL-2018-03-A-EN). Recommended cleaner is Würth Metal cleaner 7063 or Loctite cleaner 7063.

Bond the bushes in place as per the AMM with Loctite 638
Grease the bushing in the lower connection before fitting the upper mast.

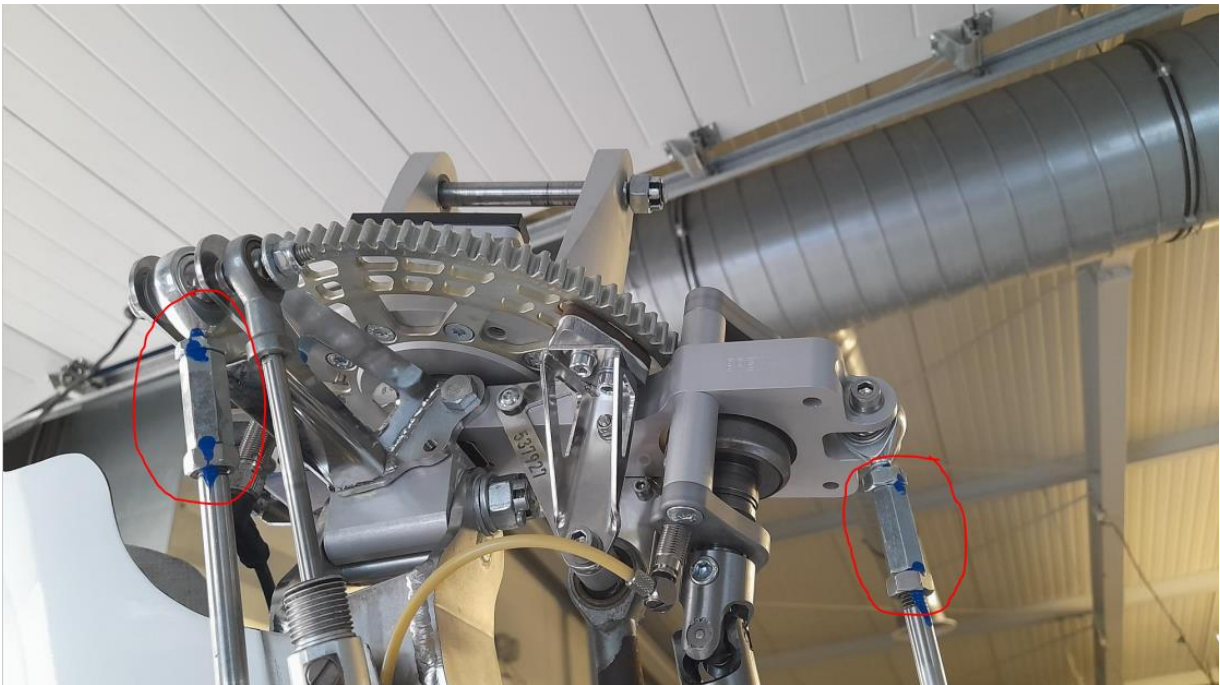
It may be necessary to extend the control push pull cables for the rotor head III upgrade. Extension pieces are provided, 30mm for roll and 40 mm for pitch PPC. A new ball end is included in the set. After finishing the installation of rotor head III and checking/adjusting the steering angles the extension pieces must be secured with mechanic lacquer.

Ensure a minimum of 6 threads engagement within the extension piece, with a locknut either end.

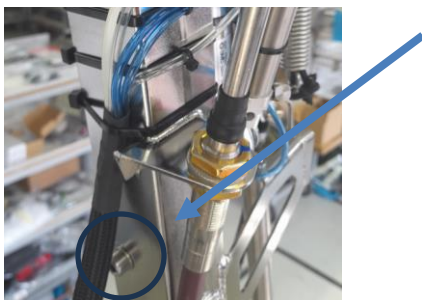
- 11.) Remove the coupling III if installed. Update to IV.1 is required for rotor head III and the higher pre-rotation rpm. De-installation is described in job card 63-11-10 4-1, step 1-4. Installation of coupling IV or IV.1 will be added to the AMM but is similar to the installation of coupling III and job card 63-11-40 4-1, step 5-9 and considered self- explanatory.
- 12.) Check the angles of the rotor head III according to 62-32-00 6-1 and adjust if necessary.
- 13.) Fit the front mast cowl. The upper mast carries a new location to secure the front cowling. Fit the black plastic spacer over this welded-on lug, and drill a hole in the cowl to match. Secure with the provided M5 fastening.

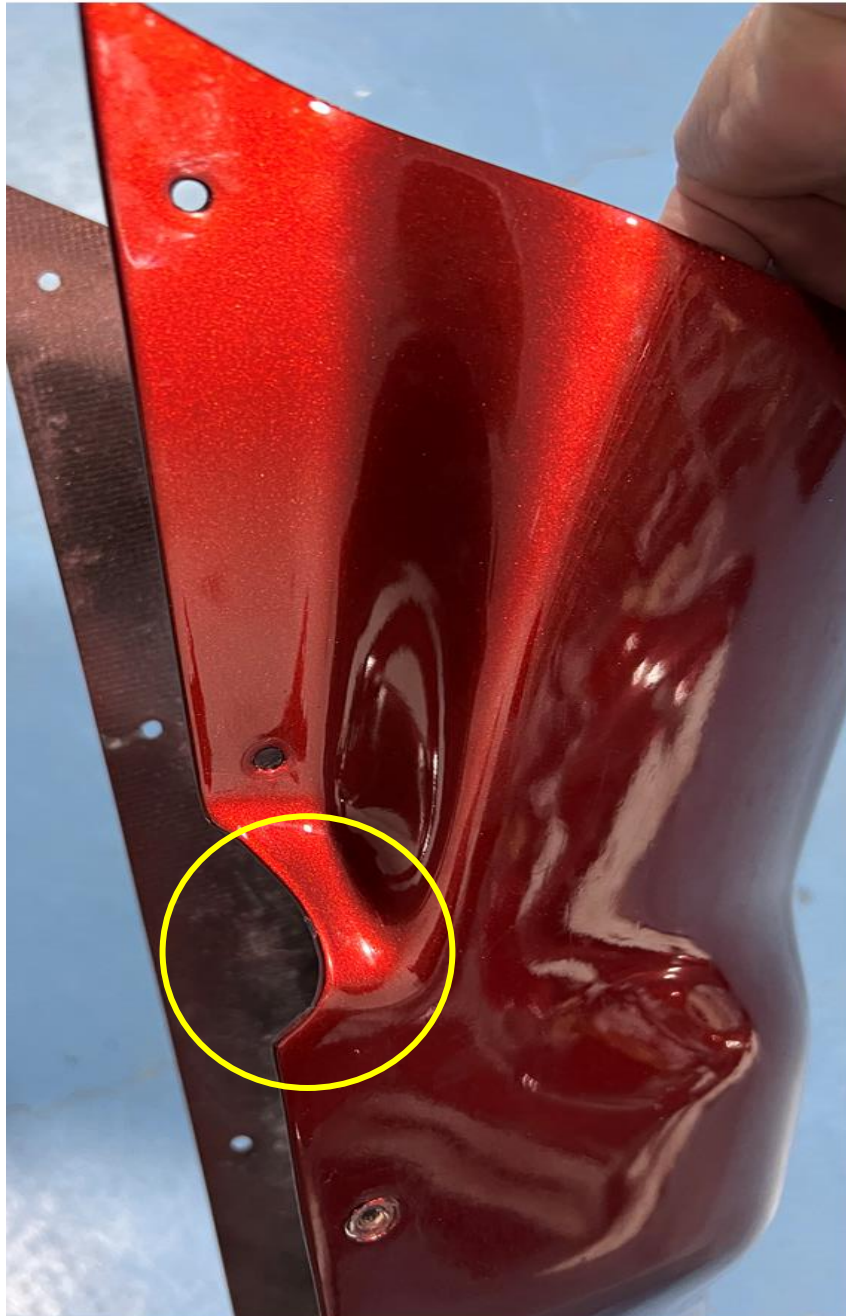
- 14.) If everything is inspected check the fitting of the cowling. Due to the rotor head upgrade it needs to be reworked.

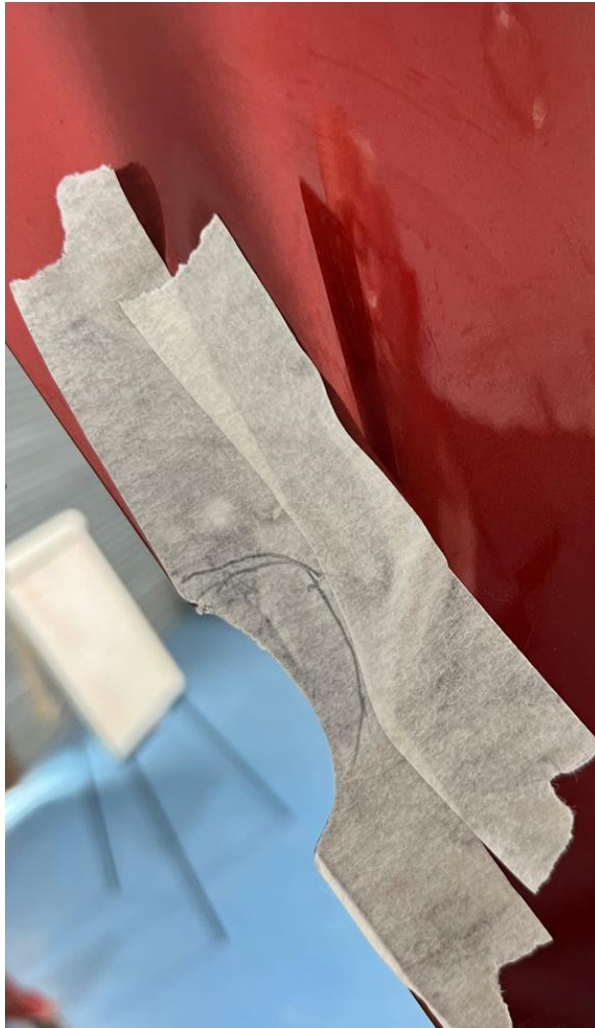
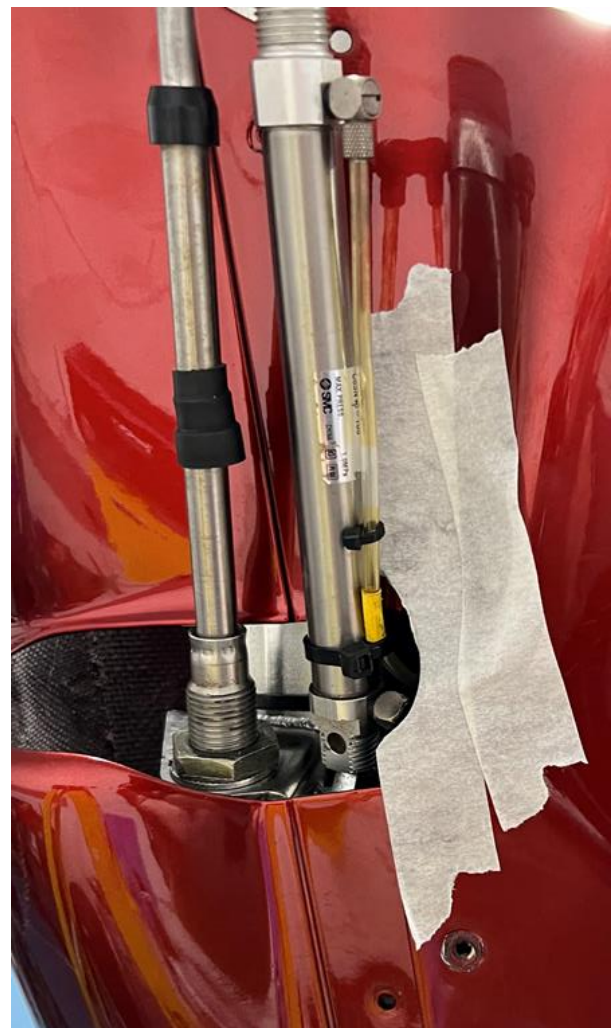
Mark the edge of the part and carefully grind a little bit away until the cowling can be installed without touching any moving part.

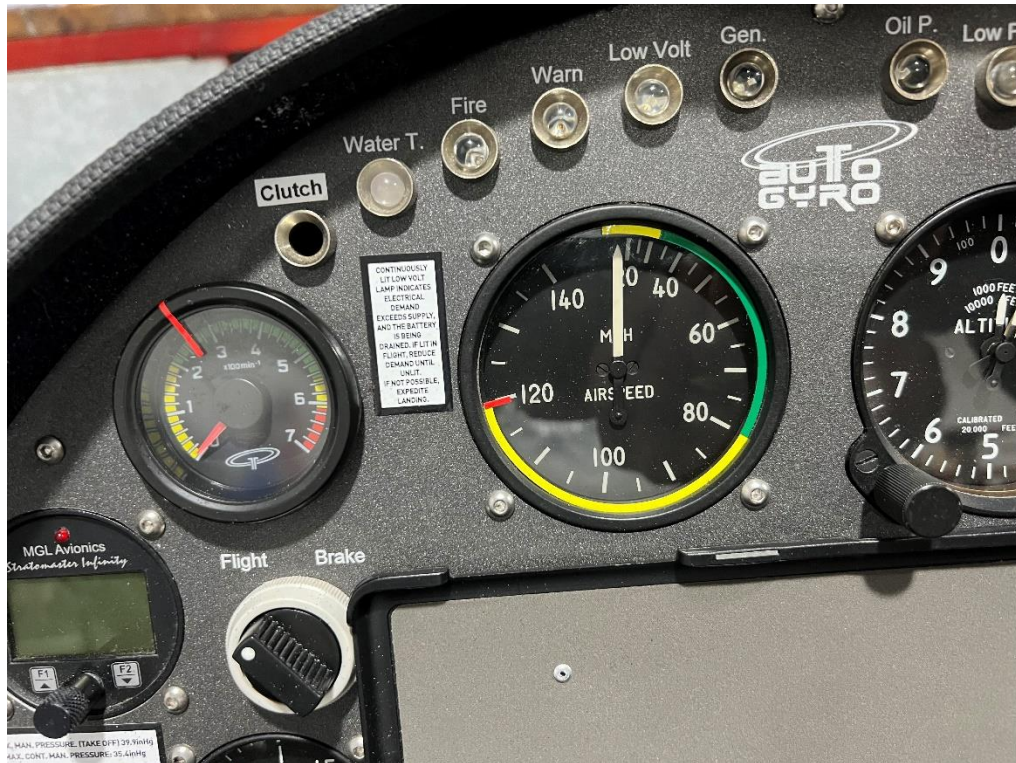
15.) Retrofit of the clutch LED

Possible LED position. A placard needs to be added to the cockpit panel.

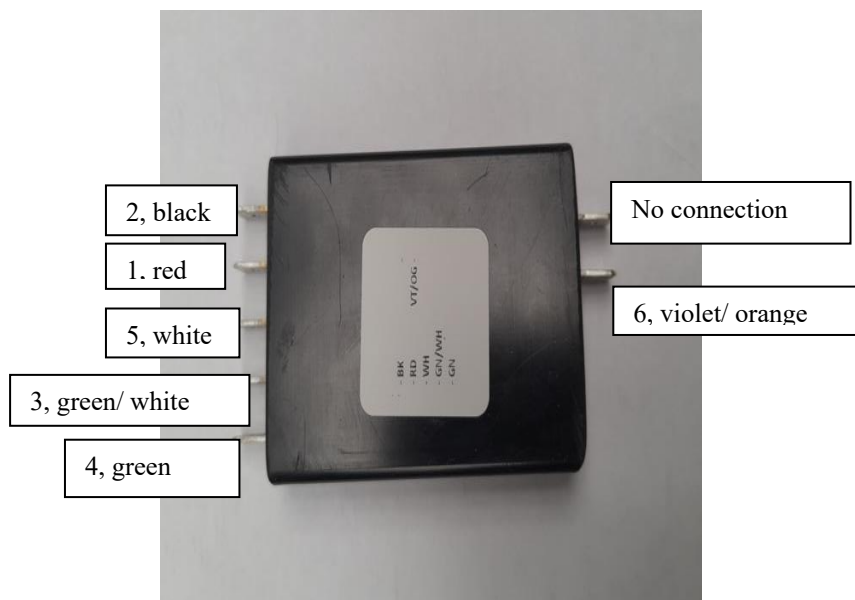
Cable colour positions are described on the rear of the clutch control board. Numbers in the photo below relate to the numbers in the circuit diagram above.

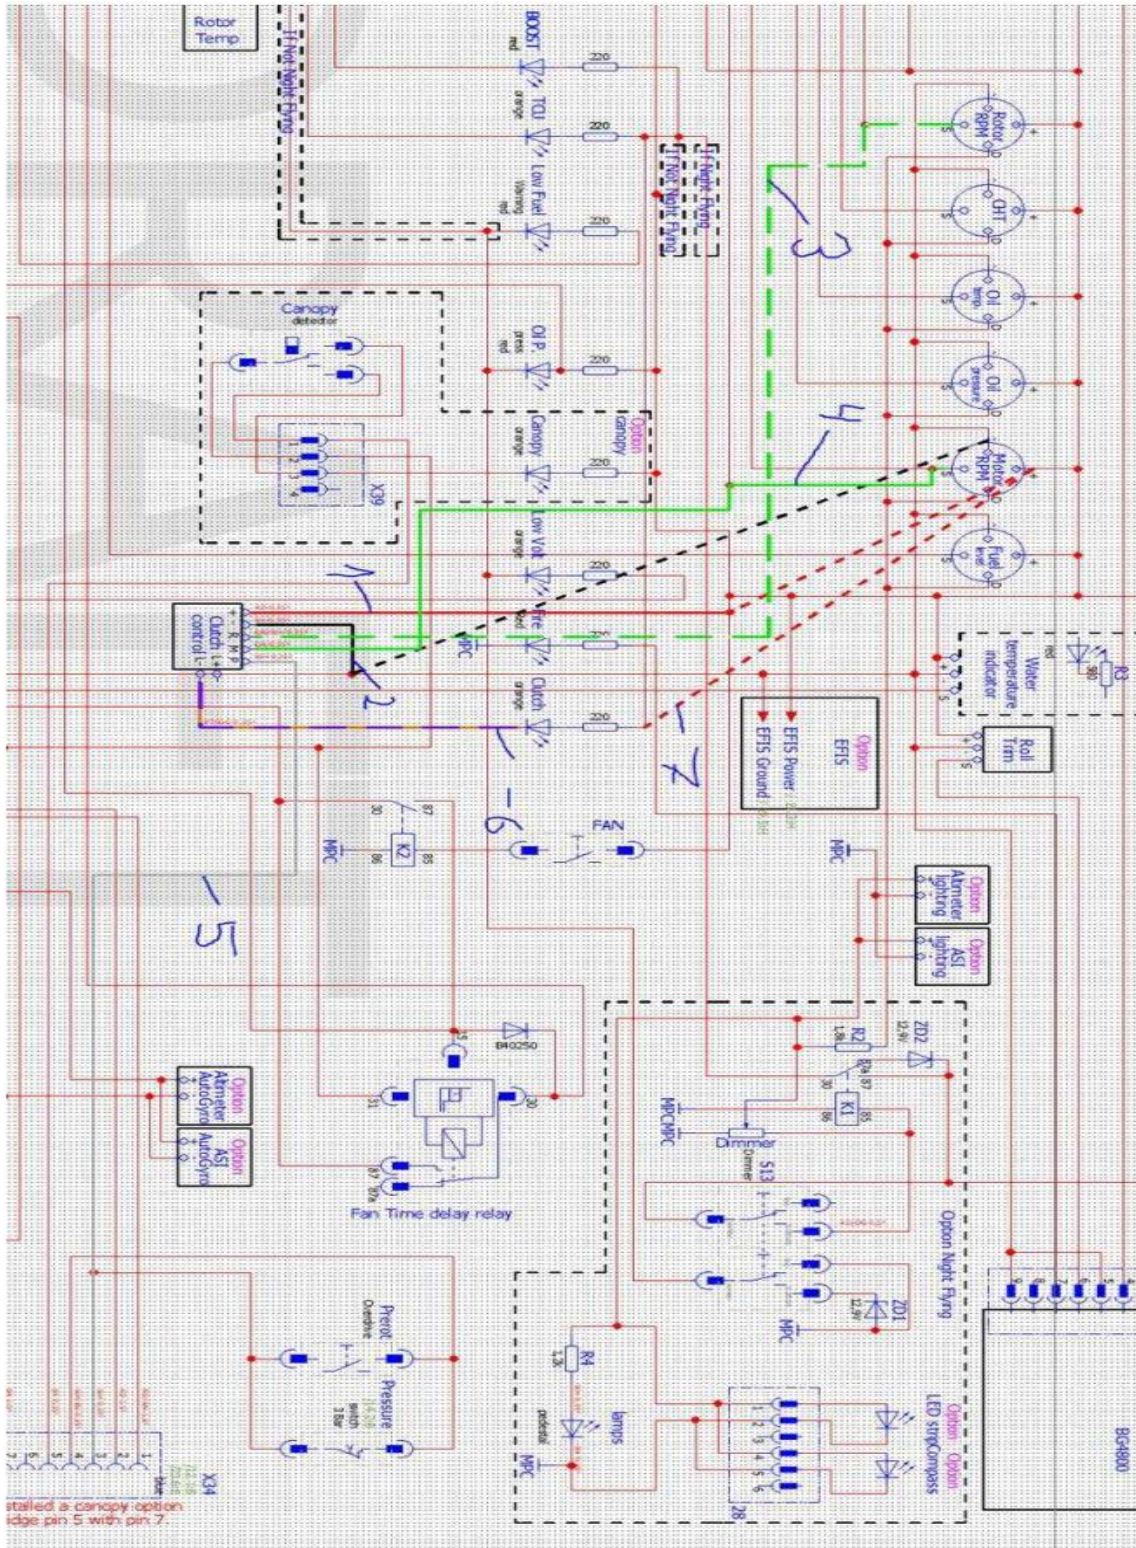
Connections 1 to 4 and 7 can be connected directly to the respective instrument (rotor rpm/engine rpm) connections. Connection 5 is pinned in position 3 of the 9-pole plug from the cockpit side of the stick harness. The opposite ends of cables 1 to 6 must be connected to the clutch control board in the positions shown, and 7 to the LED, along with the plus cable from the instrument.
