Title: Information about the actual used rubber bushes in the mast		
AG-SIL-2024-01-EN		Released:
Applicability		
Aircraft type & model: Cavalon, Calidus (and MTO2017 with separated upper mast)	Affected Serial number(s): All Models with separated upper masts	1st March 2024
The maintenance manual to be referenced is this stated or subsequent issue.		As per AutoGyro website
This form is the response from AutoGyro GmbH either against a problem found in the product in service requiring a containment or rectification action, or as service information for aircraft modification incorporation. For help, contact AutoGyro, email: airworthiness@auto-gyro.com .

Reason and overview of the Service Information Letter

The current Cavalon and Calidus Maintenance Manual job card 62-51-00 8-1 mast bushing replacement process is based on the original twin rubber bush design. For newer models the information shown is no longer correct. There is now a metal bushing assembled in the lower mast attachment. The information below explains the difference in the assembly for the lower metal bushing.

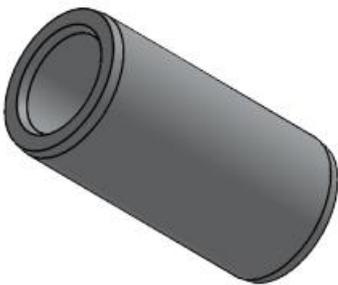
Bushing TEF-MET, PN 45861

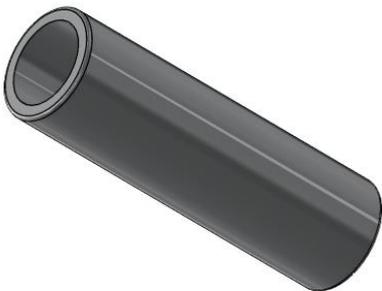
Bush mast top bottom, PN 45827

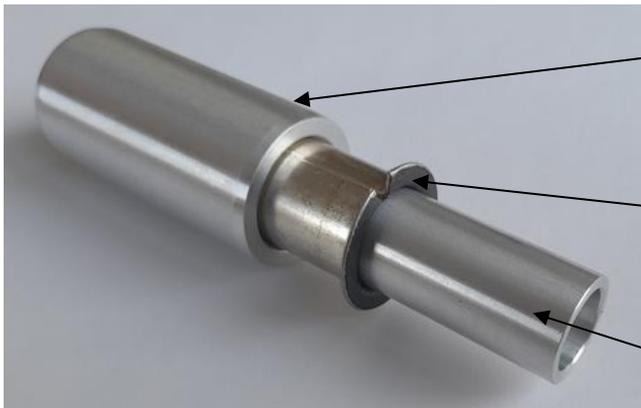
Clamp bush mast, PN 45826

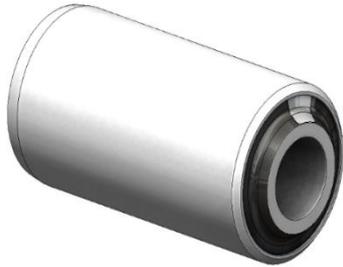
Rubber bushing, 70 shore, PN 22545 for the upper attachment point for the Cavalon. Colour marking on the rubber: white

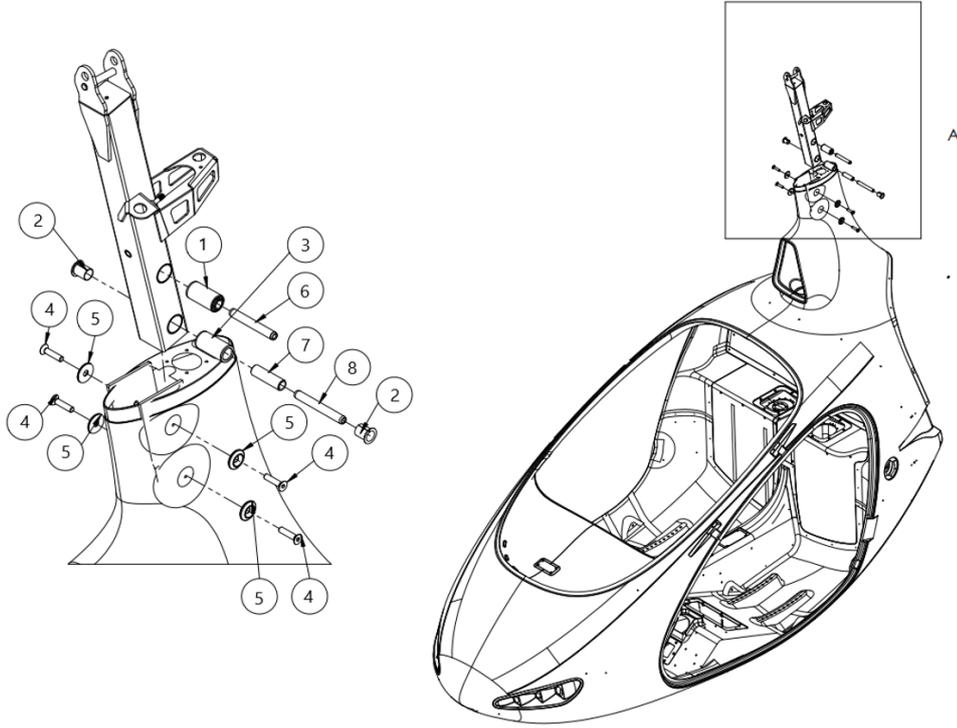
Illustrations and parts for the upper attachment for the Cavalon:

The parts for the lower attachment point for the mast are the same for Cavalon and Calidus.

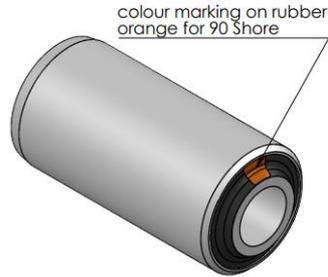
Rubber bushing, 90 shore, PN 11082 for the upper mast attachment for the Calidus. Colour marking on the rubber: orange

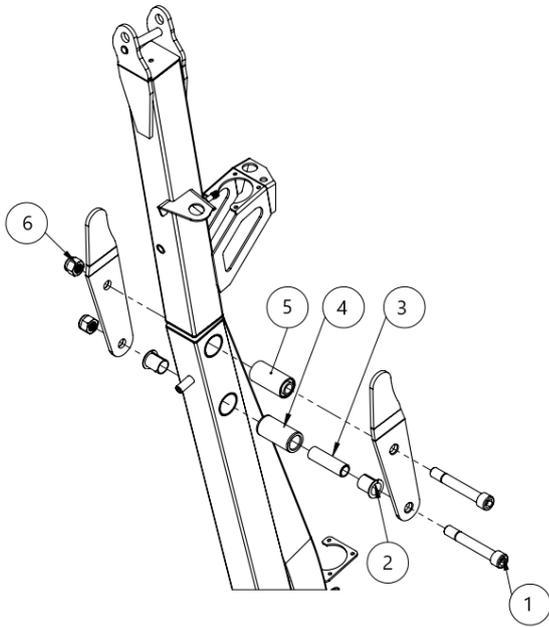
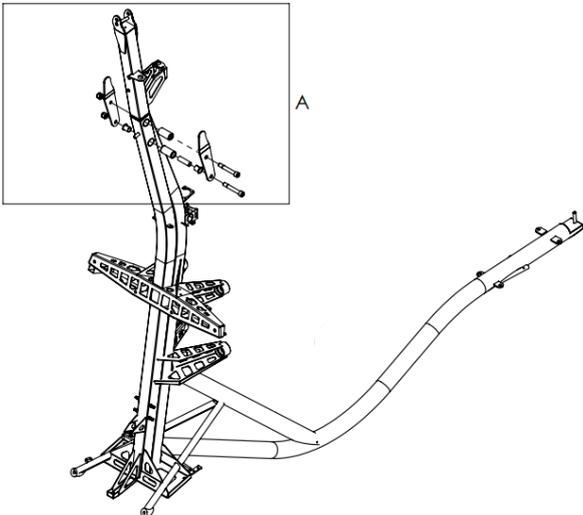
Illustrations and parts for the upper attachment for the Calidus:

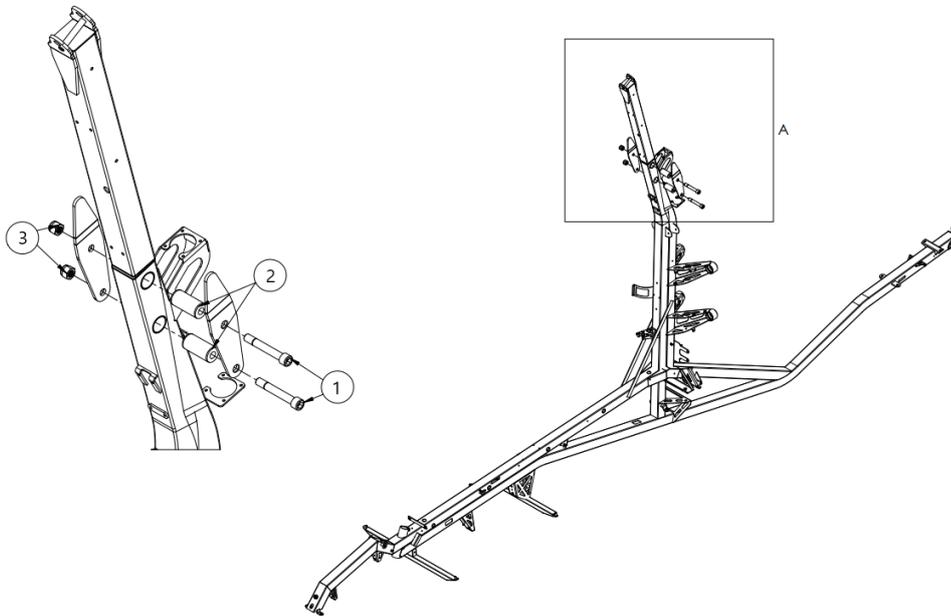
For the MTO2017 with the separated upper mast following parts are the latest development stage:

Bush mast top, PN 44214, on both attachment points
