Title: Pre-flight and maintenance inspection tasks for exhaust Rotax 916iS		
AG-SIL-2025	-01-EN	Released:
Applicabil	Applicability	
Aircraft type & model:	Affected Serial number(s):	01.03.2025
All aircrafts equipped with Rotax 916iS	all	
The maintenance manual to be referenced is	this stated or subsequent issue.	As per AutoGyro website

Reason and overview of the Service Information Letter

The aim of this SIL is to raise awareness to complete exhaust system crack checks as part of the pre-flight inspection in accordance with the manufacturer's documentation. Lack of attention to detail of pre-flight inspections can lead to potentially harmful situations as in the example below, which is specific to the Rotax 916 iS engine aftermuffler.

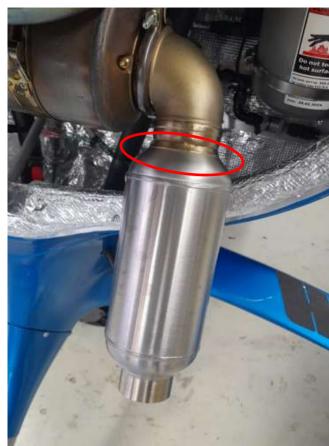
Remains after the aftermuffler shell has detached in flight

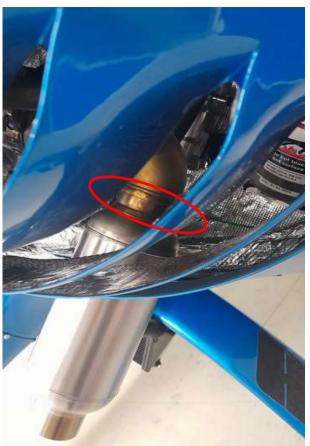
Welding seam which has to be checked

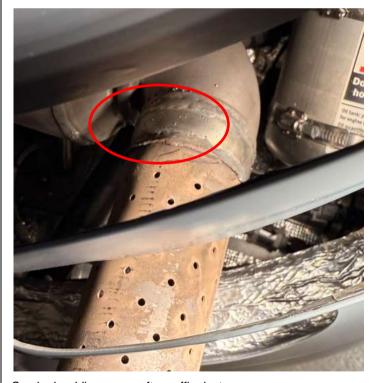
Welding seam is visible with installed cowlings
