Title: Heater Upgrade II.1		
AG-SB-2023-05-B-ENR1	Effective Date: 01.12.2023	Compliance Category: A - MANDATORY B - RECOMMENDED C - OPTIONAL
Applicability		
Aircraft type & model: Cavalon	Affected Serial number(s): built after 05/2022 and before 10/2023	
The maintenance manual to be referenced is this stated or subsequent issue.		As per AutoGyro website
This form is the response from AutoGyro GmbH either against a problem found in the product in service requiring a containment or rectification action, or as service information for aircraft modification incorporation. For help, contact airworthiness@auto-gyro.com .

Reason and overview of the Service Bulletin (cause of problem if known)

A number of early generation heater-valve units were found to be defective and started to leak. This early generation is now superseded by a new design, shown in service to be more reliable.

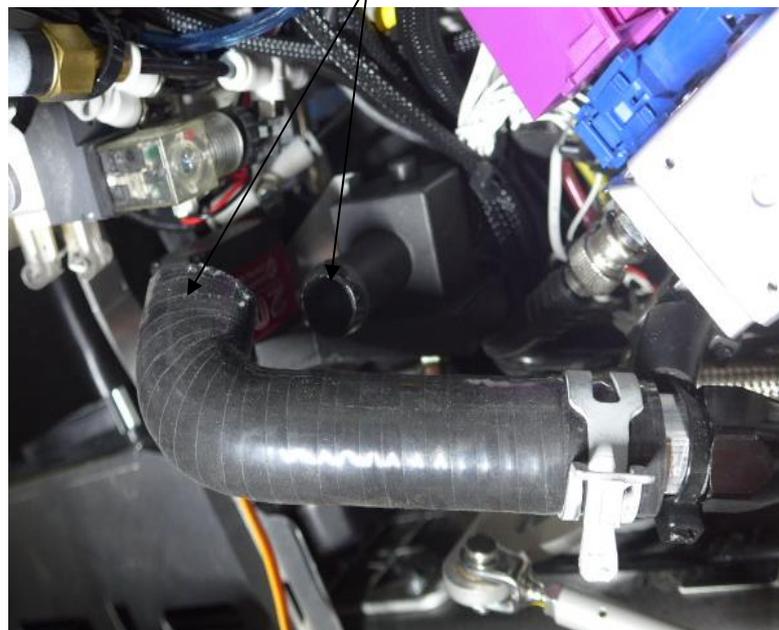
Clamp removed, hose removed from old valve unit, here to see on the left side, same on the other side with the clamp

- 5) Replace the old with the new valve unit and reconnect the Servo. Before re-installing the unit a functional check of potentiometer and valve has to be performed.
- 6) Connect the new valve unit electrical cable. Turn the key switch on, ensure that the valve opens and closes proportionally to the amount that the 'Temp' rotary knob rotates
- 7) Fully rotated left; the valve should be closed. Fully rotated right, the valve should be fully open. Look down the end of the valve to see this
- 8) Turn the key switch off if satisfactory
- 9) Fit the new valve unit, making sure the hose clamps are properly positioned. See photos below
