# AutoGyro Certification Ltd Service Bulletin (CofA)

<b>Title: CavalonPro Stability and Vibration Reduction upgrade</b>		<b>Release date 05.05.2022</b>
<b>SB-C-007 Iss1</b>	<b>Related documents</b> Modification: MC-432 engine brace MC-425 teeter tower height change MC-384 mast bushes MC-382 New rotor head with higher pre rotation and Vne CCAR No.: None	<b>Compliance Category:</b>  <b>OPTIONAL</b> or <b>RECOMMENDED</b> or <b>MANDATORY</b>
<b>Applicability</b>		
<b>Aircraft type &amp; model:</b> All UK registered CavalonPros	<b>Aircraft serial Nos. affected:</b> All, as applicable	
The maintenance manual to be referenced is this stated or subsequent issue.		RSUK0335
<p>This form is the response from AutoGyro Certification Ltd either against a problem found in the product in service requiring a containment or rectification action, or as service information for aircraft modification incorporation. For help, contact RotorSport on 44(0)1588 505060, or email <a href="mailto:compliance@rotorsport.org">compliance@rotorsport.org</a>.</p> <p>The technical content of this document is approved under the authority of the UK CAA Design Organisation Approval Ref: <b>DAI/9917/06</b></p>

<b>Title:

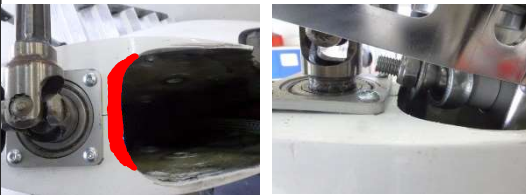
<p>Bearing Retaining Collar</p>
5	It may be necessary to remove material from the composite web between mast rear face/brake-trim cylinder, and pre-rotator drive shaft bearing retaining plate. There must be a minimum of 3mm material visible forward of the forward edge of the drive shaft bearing retaining plate after any re-work.

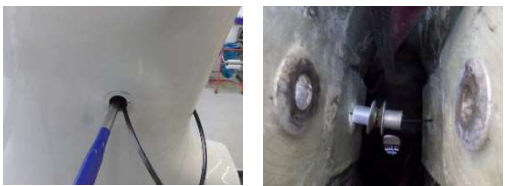
6	If the lower bush in the original mast assembly is the rubber variant it will be necessary to remove the old bushes in the fuselage and insert new from the upgrade set. Insert a cable tie around the fuselage mast and through the bushes. Using a suitable punch, carefully drive out the bushes from outside to inside.

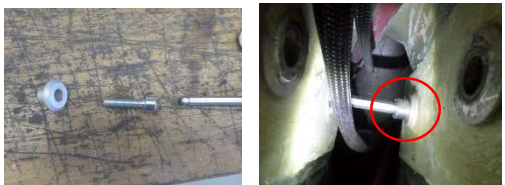
7	Clean and degrease the inside surfaces of the holes and using a suitable tool and bolt, carefully press the 2 new bushes (23901) from the inside into the respective holes left and right of the fuselage mast.

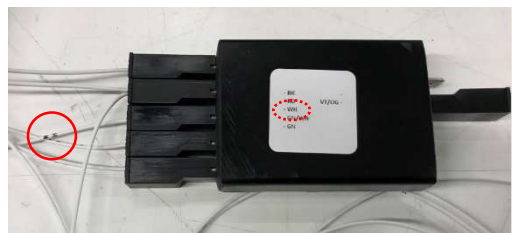
17	Connect the cables from set 46141 to the control unit using cable markings and control unit label as reference.

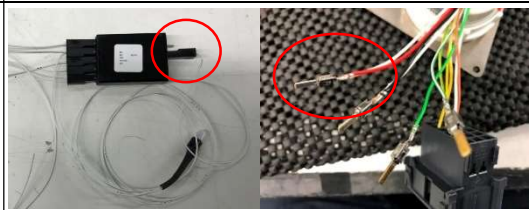
18	Crimp a positive lock contact to cable VT/OG from the LED and connect to the control unit. Crimp the RD/BR cable to the red cable of the grey 18 pin plug.

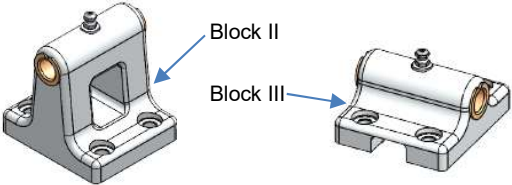
<i>Tail plane angle check</i>	
30	<p>If the keel tube is not to be replaced, carry out a tail plane angle check.</p> <p>Refer to module "Keel Tube I to II Upgrade" serial 29.</p> <p>If it is not possible to attain the correct tail plane angle with the maximum amount of spacers, it is strongly recommended that the keel tube be replaced with the newest version.</p> <p><b>If this is not undertaken it may result in poor flight characteristics of the aircraft.</b></p>
<i>Functional checks</i>	
31	<p>Carry out a ground run for functional and proof checks of the pre-rotator system and indication.</p>
<i>Final steps</i>	
32	<p>Replace teeter block II with teeter block III on the rotor system using AMM job card 62-11-00 6-3 as reference.</p>

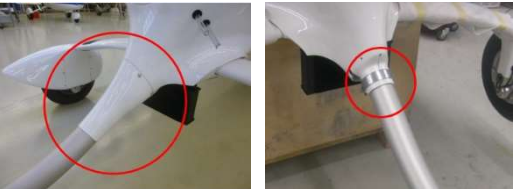
11	Remove the keel tube clamp cover and slide rearwards along the keel tube. Loosen the keel tube clamp and slide rearwards along the keel tube.

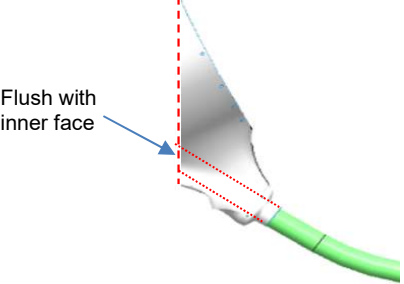
17	Feed the keel tube through the composite of the clamp. Apply a thin film of locally procured Paste 20 or equivalent (eg. Six10 Thickened Epoxy Adhesive) to the relevant areas of the keel tube at the bulkhead tube and clamp shoulder before inserting into the composite. Gently push the tube into position into the engine bulkhead composite tube. The end of the keel tube should be flush with the forward face of the engine bulkhead. <b>Note: It is important that the next step be carried out IMMEDIATELY, before the epoxy sets.</b>

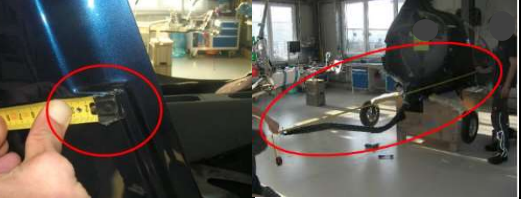
18	Place the keel tube clamp in position and tighten lightly to allow some movement in the keel tube. Centralize the keel tube by taking measurements from the lower corner of the cabin door hand recess to rudder pin. Align the keel tube so that the distance between rudder pin and lower corner of the cabin door hand recess is equal on both sides and tighten the clamp to 10Nm. Allow the epoxy to harden overnight (minimum 12 hrs).

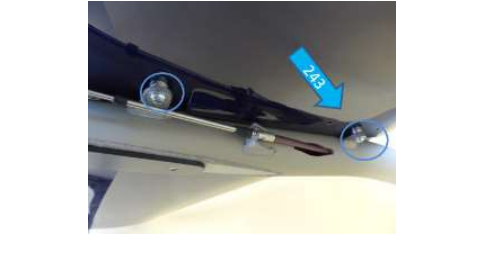
27	<p>Assemble the tail plane to the keel tube using the same combination of spacers and washers that were previously removed from each mounting point using Loctite blue 243 (10Nm). Ensuring the flooring is horizontal, measure from each trailing edge corner to the ground. The difference should not be greater than 10mm. Add washers to both mountings on the one side to adjust as required.</p>

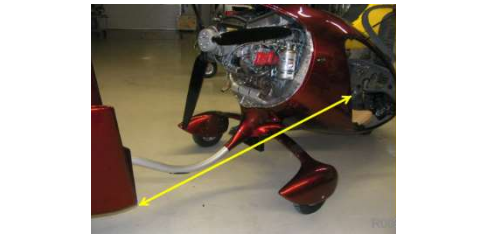
28	<p>Check alignment of the tail plane to fuselage. Measure the distance from the lower corner of the cabin door hand recess to the outer forward corner of the tail plane. The distance of the starboard measurement should be 20mm +/-5mm <i>shorter</i> than the port. If this is not the case, loosen the mounting bolts, adjust and re-tighten.</p>

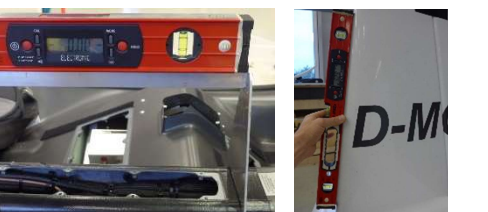
29	<p>Check the tail plane angle. Place a suitable digital spirit with level mounting plate tool (48006) on the center console and set to zero. Place the spirit level on the leading edge of the vertical fin of the tail plane and measure the angle. The angle should be 82.0° +/- 1.0°.</p>

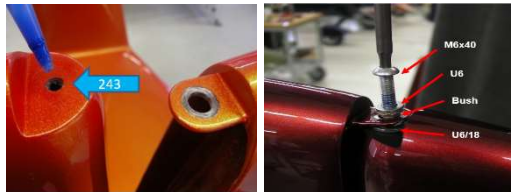
33	<p>Apply Loctite blue 243 to the thread in the rudder. Assemble the upper rudder attachment. The M6x40 attachment screw should be tightened until there is minimal vertical play. The joint in the bush must be orientated to the front. Lubricate the joint with HHS2000 spray or equivalent.</p> <p><b>ATTENTION: The screw and bush MUST turn with the rudder.</b></p>

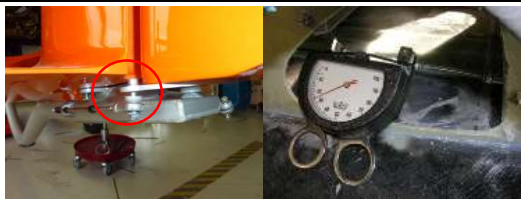
34	<p>Assemble the screw, washer (above the steering plate) spacer, rudder cable ball-end, washer and nut to the rudder, and tighten.</p> <p>Check the tension of each cable (the steering yoke should still be locked in a central position with the pins).</p> <p>Adjust at the ball ends until a tension of 25lbs +/- 5lbs is achieved in each cable.</p>

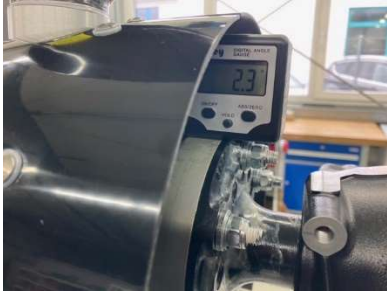
<div style="border: 1px solid red; padding: 5px; color: red; width: fit-content; margin-left: 10px;"> <b>Re-assemble with 1 x 9mm spacer only</b> </div>
7	<b>FOR THE CAVALON 915iS VARIANT ONLY:</b> Check the engine thrust angle. Using 0° at the center console as the reference point, place a suitable digital spirit level on the top of the propeller gearbox spacer or propeller flange face and measure the thrust angle. The angle should be 0° (max 0.5° nose down, 1.0° nose up). If this cannot be achieved then AutoGyro ( <a href="mailto:airworthiness@auto-gyro.com">airworthiness@auto-gyro.com</a> ) should be contacted.

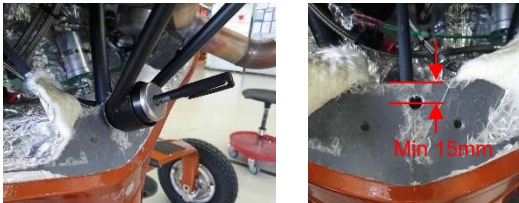
7	Rotate the support arm into position and mark the position of the hole onto the fuselage. There must be a minimum of 15mm material from the center of the hole to the upper edge of the composite. If this is not the case, use U10/30 washers to shim the support arm rearwards to achieve this. Drill a 10.5mm hole in the marked position.

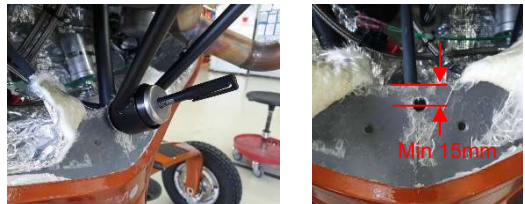
14	Rotate the support arm into position and mark the position of the hole onto the fuselage. There must be a minimum of 15mm material from the center of the hole to the upper edge of the composite. If this is not the case, use U10/30 washers to shim the support arm rearwards to achieve this. Drill a 10.5mm hole in the marked position.
