<b>Title: Cavalon Market Upgrade</b>		
<b>AG-SB-2021-06-C-EN</b>	<b>Effective Date:</b> 29.11 2021	<b>Compliance Category:</b>  <b>A - MANDATORY</b> <b>B - RECOMMENDED</b> <b>C - OPTIONAL</b>
<b>Applicability</b>		
<b>Aircraft type &amp; model:</b>  AutoGyro Cavalon	<b>Affected Serial number(s):</b>  All AutoGyro Cavalon 912, 914 & 915iS	
The maintenance manual to be referenced is this stated or subsequent issue.		As per AutoGyro website
This form is the response from AutoGyro GmbH either against a problem found in the product in service requiring a containment or rectification action, or as service information for aircraft modification incorporation. For help, contact <a href="mailto:airworthiness@auto-gyro.com">airworthiness@auto-gyro.com</a> .

### **Reason and overview of the Service Bulletin (cause of problem if known)**

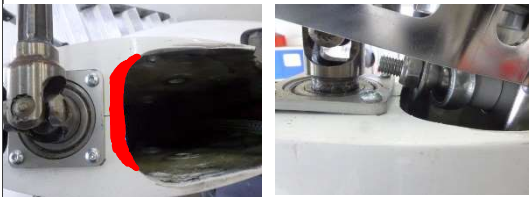
<p>Bearing Retaining Collar</p>
5	It may be necessary to remove material from the composite web between mast rear face/brake-trim cylinder, and pre-rotator drive shaft bearing retaining plate. There must be a minimum of 3mm material visible forward of the forward edge of the drive shaft bearing retaining plate after any re-work.

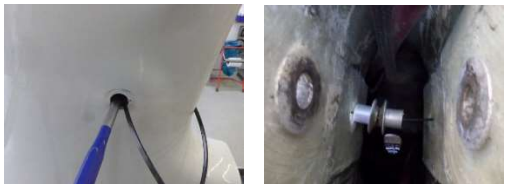
6	If the lower bush in the original mast assembly is the rubber variant it will be necessary to remove the old bushes in the fuselage and insert new from the upgrade set. Insert a cable tie around the fuselage mast and through the bushes. Using a suitable punch, carefully drive out the bushes from outside to inside.

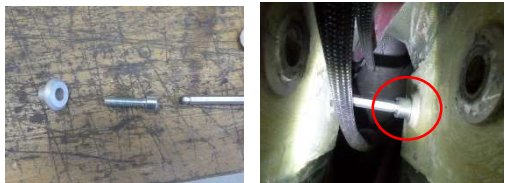
7	Clean and degrease the inside surfaces of the holes and using a suitable tool and bolt, carefully press the 2 new bushes (23901) from the inside into the respective holes left and right of the fuselage mast.

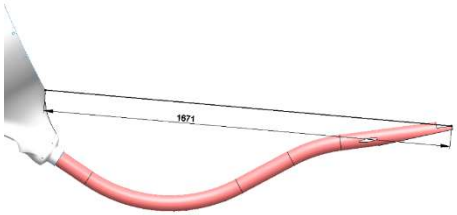
<p>Keel tube I – short (1671mm)</p>

<p>1</p>	<p>If the Cavalon is fitted with keel tube I (short version) it <b>MUST</b> be upgraded to keel tube II when upgrading from rotor head II to rotor head III.</p>

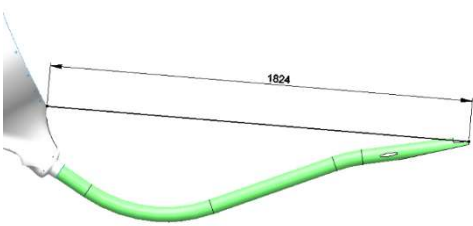
<p>Keel tube II – long (1824mm)</p>
<p>2</p>	<p>Remove the left and right rudder control cable to rudder bolts Note the position of washers and spacer when removing.</p>

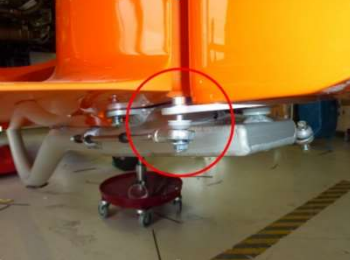
<p>3</p>	<p>Supporting the rudder, remove the upper bolt, bush and washers. Note the position of items for re-fitment. Tilt the upper rudder slightly rearwards to clear the attachment bracket of the stabilizer, and slide upwards off of the lower bearing pin.</p>

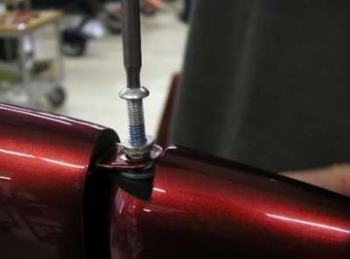
<p>4</p>	<p>Remove the 4 horizontal stabilizer attachment bolts. Note positions of spacers and washers. Remove the stabilizer from the keel tube.</p>

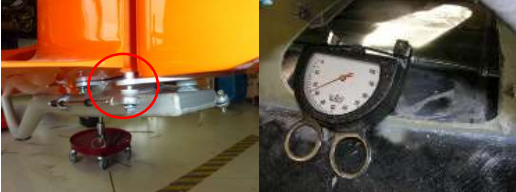
<p>35</p>	<p>Determine position of the rudder with the pedals parallel. Measuring should be carried out from the lower rear tip of the rudder, to the rear edge of the vertical fin of the tail plane, parallel to the ground. Right: 840mm +/- 10mm Left: 900mm +/-10mm Adjust the ball ends until this is achieved, retaining the same tension in the cables.</p>

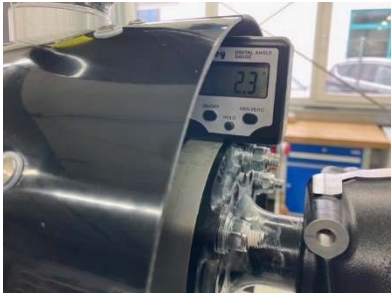
<div style="border: 1px solid red; padding: 5px; display: inline-block; color: red; font-weight: bold;">Re-assemble with 1 x 9mm spacer only</div>
7	<b>FOR THE CAVALON 915iS VARIANT ONLY:</b> Check the engine thrust angle. Using 0° at the center console as the reference point, place a suitable digital spirit level on the top of the propeller gearbox spacer or propeller flange face and measure the thrust angle. The angle should be 0° (max 0.5° nose down, 1.0° nose up). If this cannot be achieved then AutoGyro ( <a href="mailto:airworthiness@auto-gyro.com">airworthiness@auto-gyro.com</a> ) should be contacted.

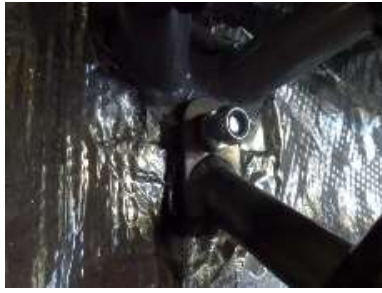
21	<p>Adjust the length of the arm at the center threaded joint so that the lower attachment stub aligns with the assembly hole.</p> <p>The face of the attachment stub must be parallel to the rear face of the fuselage composite.</p> <p>If there is a gap between assembly stub and composite when the faces are parallel, shim with U10/30 washer if required.</p> <p>Insert the bolt through both arm assemblies from inside the engine compartment as shown and secure with the M10 Nyloc nut.</p>

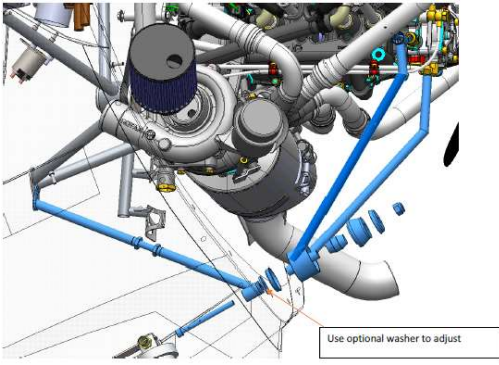
22	Remove the support arm upper attachment bolts one at a time, apply Loctite blue 243 and re-assemble then tighten.
